#### On-orbit Power Fluctuations of ADEOS-II

#### **ABSTRACT**

Since ADEOS-II was launched, JAXA has analyzed on-orbit telemetry routinely in order to verify design and to find any sign of anomaly or degradation. One of the findings is generation power fluctuation of solar array paddle. We have investigated mechanisms of the power fluctuation and reached a scenario, space debris impact on solar cell. The impact might cause short circuit in solar array paddle and drop generation current. To confirm the scenario, we carried out hypervelocity impact tests to the solar array blankets. The investigation and test result are reported in this paper.

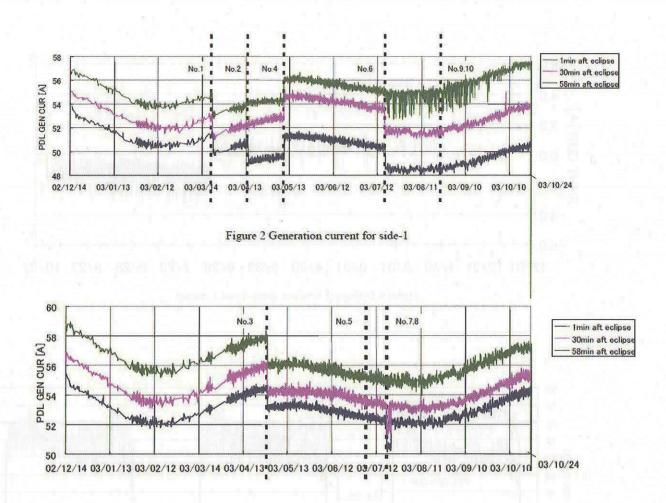
Figure 3 Generation current for side-2

We found first 100 W power fluctuation on March  $20\text{th}\ 2002$ . The long term plots from December 2002 to October 2003 for Solar Array generation current are illustrated in Figure 2 and 3 for side 1 and 2 respectively. To identify the power fluctuation occurring timing, current data measured 1, 30 and 58 minutes after end of eclipse were plotted. 58 minutes after end of eclipse corresponds to just before start of next eclipse. Bus voltage is almost 50 V therefore 100 W in power corresponds to 2 A in current.

10 power fluctuations on 7 solar array circuits were found for mission life of 10 months. All power fluctuations were 100 W steps and occurred in Side-1 or 2 independently. Some power drops returned to previous states during the sunlit or some days after the drop.

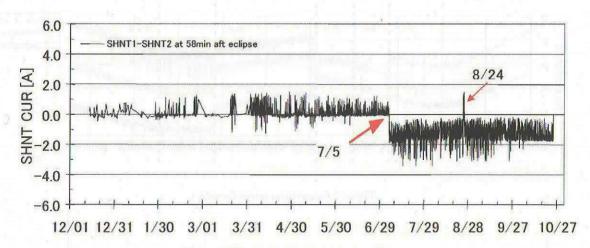
Figure 4 Difference between shunt -1 and 2 current

Difference between Shunt circuit side-1 and 2 was plotted in Figure 4. 2 A offset was found on July 5th and

August 24th. Latter continued only 1 day and returned to nominal state on August 25th. No change in generation power was found even if the Shunt current fluctuated.

Shunt circuit is controlled by detected bus voltage automatically. Therefore Shunt-1 and 2 should operate simultaneously. In nominal, the difference between Shunt-1 and 2 current becomes zero. Assuming short circuit between power hot lines, the phenomena can be explainable. If an array circuit transmits 4 A, generation current, defined as PCU input current + Shunt current, didn't change. However, when a shunt circuit dissipated 4 A, 2 A difference between shunt 1 and 2 appeared. Additionally, temperature drop was found in PDM, therefore short circuit must occur on Solar Array Paddle or Power harness.

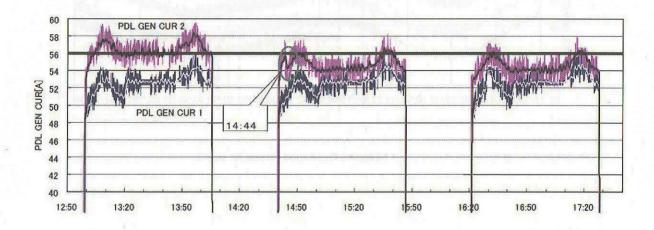
Figure 5 Generation Current Drop on April 29th

From the start of sunlit, generation power is lower by 100 W and the situation continued during whole sunlit. This was found on March 20th and April 29th. The generation current plot for 3 orbits on April 29th is illustrated in Figure 5. The power drop can be seen in the side 2 at just beginning of second orbit. The power is still low in third orbit. This is independent from shunt operation. A short circuit between Hot and Return lines or an open circuit of Blocking Diode is suspected. Considering the power drop occurred on March 20th returned to nominal state on May 9th, the possibility of a permanent failure of Blocking Diode is low.

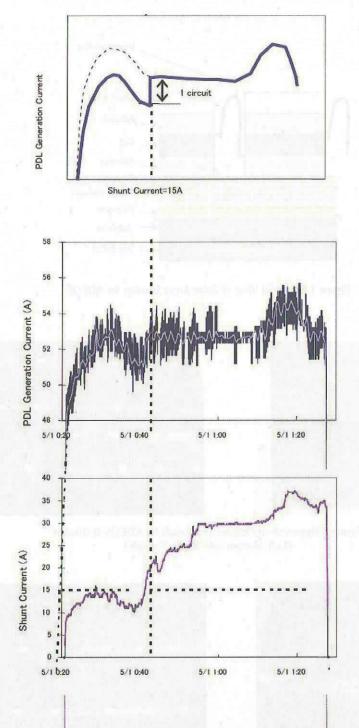
Figure 6 Relationship between Power Drop and Shunt Current

From the start of sunlit, generation power is lower by 100 W. However the power drop returns during the sunlit. This is found on April 14th, July 17th, and July 19th. Generation current and Shunt current are plotted in Figure 6. Middle is telemetry plot of generation current. It isn't easy to find a fluctuation in the plot due to noise, so schematic figure is shown in upper. Power returned at curtain shunt current level. This is found in each orbit. Assuming a short circuit between hot and return line with small resistance, current doesn't flow to PCU but goes to Shunt when a shunt circuit turns on.
