Investigation of an Operational Anomaly of the ADEOS-II Satellite

The ADEOS-II satellite experienced anomalous operation on October 25, 2003. The power generated on the satellite suddenly decreased from 6 kW to 1 kW. We conducted experiments to investigate this degradation of power for the satellite. The multi-layer insulator film that wraps the power cables was charged by low-energy electrons when the satellite passed through the aurora region around the Earth's pole. ESD tests were carried out for the power cables. Trigger arc discharges occurred between the film and cables with cracks produced by thermal cycles. A secondary arc electric discharge subsequently occurred between the cables themselves. This secondary arc caused a sustained arc after several discharges, which burned out the cables. The heat caused by arc tracking between the hot and return cables made them burn out. This was the mechanism of the operational anomaly on the ADEOS-II satellite.

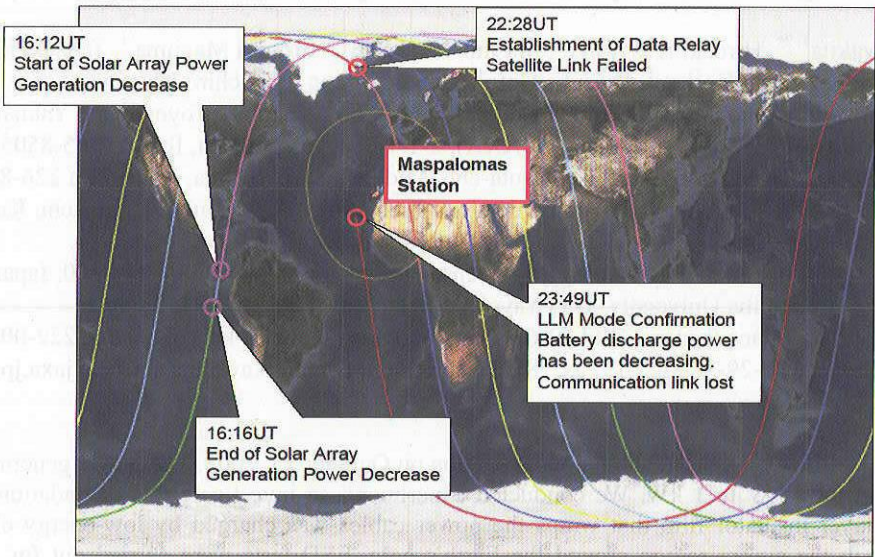
Fig.2 Location of anomaly events.

ADEOS-II suddenly stopped observing the Earth's environment at 22:18 (UT) on October 24, 2003 [5]. The satellite shifted to low-load mode because of the greatly degraded electrical power. The satellite was subsequently unable to contact the ground communication center. An analysis of the flight data revealed that the power on the satellite suddenly decreased from 6 kW to 1 kW. Figures 2 and 3 depict the location of the anomaly and power data for the flight.

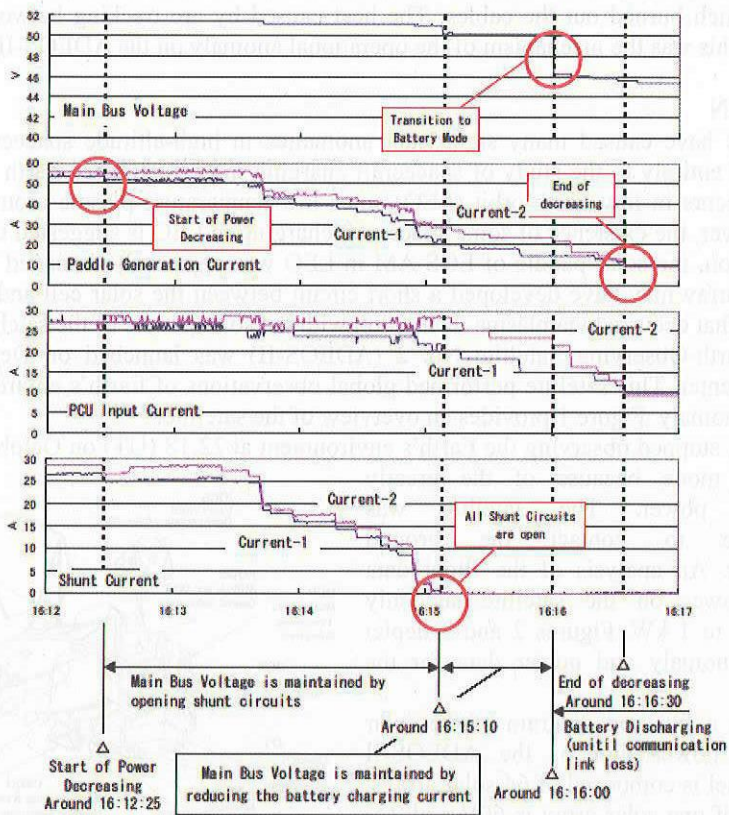
Fig. 3 Flight data of the generated electrical power on operational anomaly.

The currents of SHNT-1 and SHNT-2 decreased at about the 2A step in Fig. 3. The input current of the PCU did not change when the current of the SHNTs decreased. However, the current of the PCU began to decrease when the current of the SHNTs was 0A. The degradation of BUS voltage at 16:16 suggests the discharge of the satellite batteries. The results clearly indicate that the PCU operated normally during degradation of the electric power.

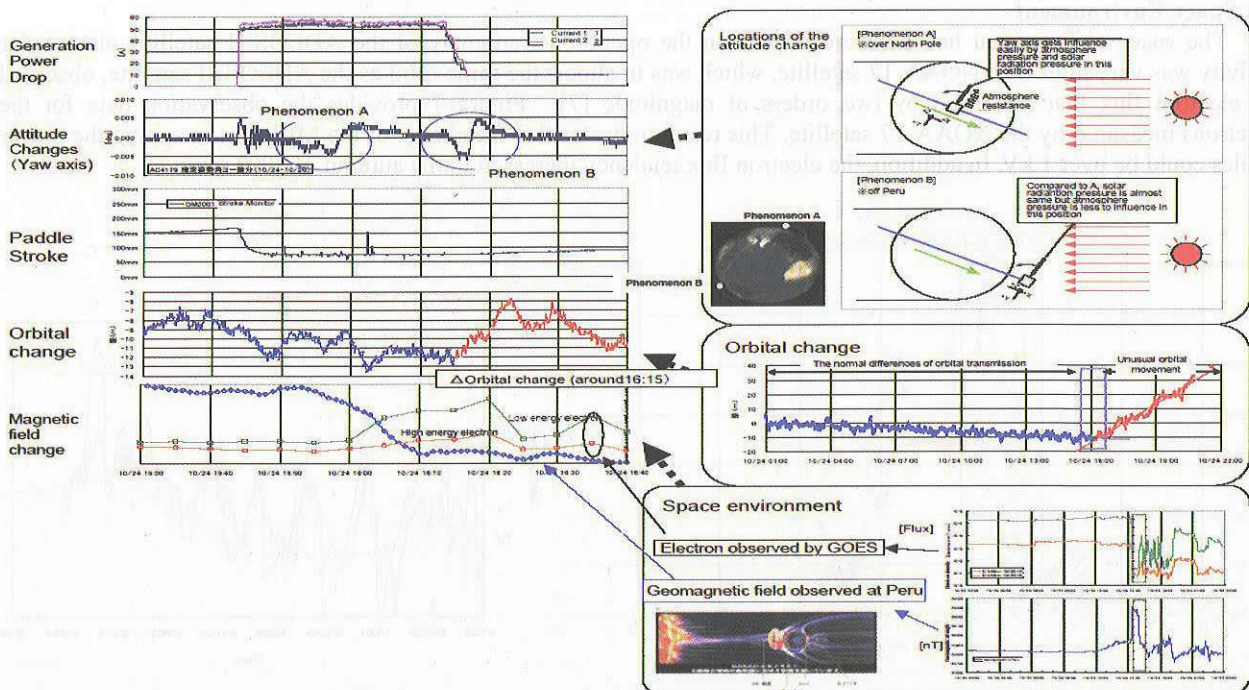
Fig. 5 Changes in attitude of the ADEOS II satellite on operational anomaly.

Figure 5 provides the flight data of the attitude of the satellite during the operational anomaly. A change of attitude was observed for five minutes at the same time as the degradation of power. In addition, the altitude of the satellite decreased. This phenomenon was not considered to be affected by space debris or meteoroids, since the attitude

fluctuation continued for a long time.

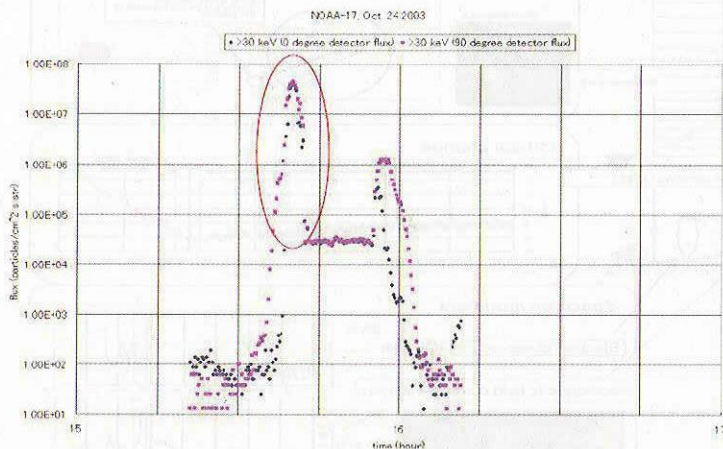
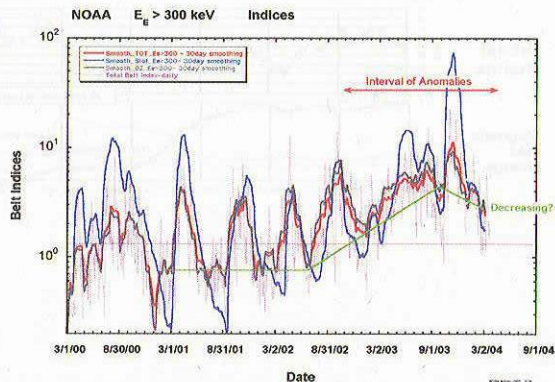
Fig. 7 Flight data of electrons measured by the NOAA-17 satellite.

The space environment had a severe impact on the operational anomaly of the ADEOS-II satellite, since solar activity was very high. The NOAA-17 satellite, which was in almost the same orbit as the ADEOS-II satellite, observed an electron flux that increased by two orders of magnitude [7]. Figure 7 provides the observation data for the electrons measured by the NOAA-17 satellite. This result indicates that the charge of the MLI film wrapping the power cables could be over 1 kV. In addition, the electron flux tendency increased in the autumn of 2003.

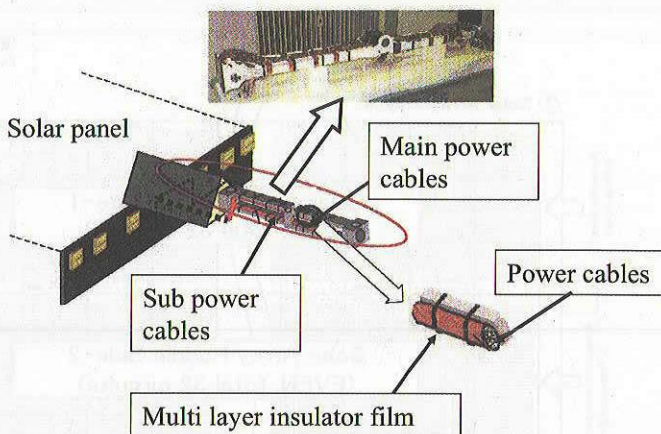
Fig. 6 Electrical power cables wrapped with a multi layer insulator on the boom of the ADEOS-II satellite.

This analysis suggests that the electrical power cable of the satellite was the failure point. The cables of ADEOS-II were bound in two parts on the boom. One bundle was composed of 52 cable pairs, corresponding to about 5kW, the other was composed of signal lines and 12 cable pairs, corresponding to about 1kW. An overview of the cables and the boom of ADEOS-II are provided in Fig. 6. The main electrical power of the cables was consistent with the satellite's loss of generated power.

The cables were wrapped in multi-layer insulator (MLI) film. This film prevents the cable temperature from dropping when solar panels are deployed in the first phases of space travel. The film has 12 layers, which are insulator

film with evaporated Al. The film floats electrically on the satellite. Thus, the MLI may be charged by low-energy electrons [6].

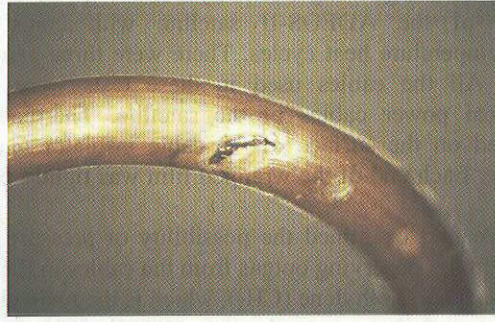
(b) Crack on the cable after test

Cracks were generated on the cables after about 5000 thermal cycles. Figure 8 (b) depicts the cracked cables after

the thermal cycle test. The cracks were produced at the sticking point between the cables caused by thermal stress.

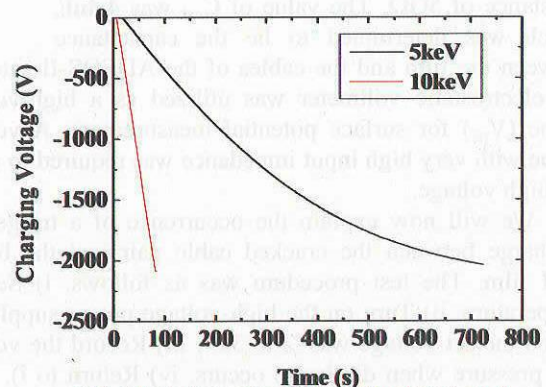
(b) Charging of a MLI film by 5 and 10 keV electrons

The MLI film of the ADEOS-II satellite would be charged by electrons while traveling across the aurora region since the film was not grounded to the satellite. We conducted a charging test for the film. Figure 9 depicts the test configuration. Electrons in energy of 5 and 10 keV were irradiated onto the film. The electron flux of 5 keV and 10 keV electrons was 1×10^7 and 1×10^8 electrons/cm², respectively. The charging potential of the film was monitored using a potential meter and a PC. The result indicated that the film was charged with enough potential to cause a discharge between the cracked cable and the film. The film charge would not be rapidly mitigated by low temperature plasma after traveling in the aurora region since electrons in a range of 10 keV to 30 keV were able to create an internal charge in the surface polyimide layer of the film [8].

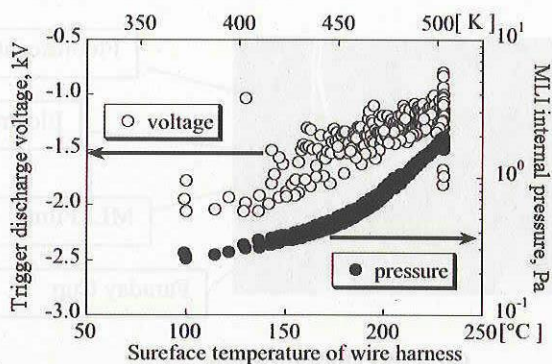
Fig. 12 Variations of the threshold voltage of trigger discharge and the MLI internal pressure.

We will now explain the occurrence of a trigger arc discharge between the cracked cable pair and the biased MLI film. The test procedure was as follows. i) Set the temperature. ii) Turn on the high-voltage power supply, for which the set voltage was -2 to 3kV. iii) Record the voltage and pressure when discharge occurs. iv) Return to i). Both SASs were turned off during this examination. Figure 12 illustrates the relationship of the threshold voltage of the trigger discharge and the film's internal pressure with changes in the surface temperature. We confirmed that the threshold voltage of the trigger discharge became lower with increases in the internal pressure of the MLI, as described above. The threshold voltage at 230°C was -1.0 to 1.5kV, which is a reasonable potential for the film when charged by low-energy electrons in orbit.

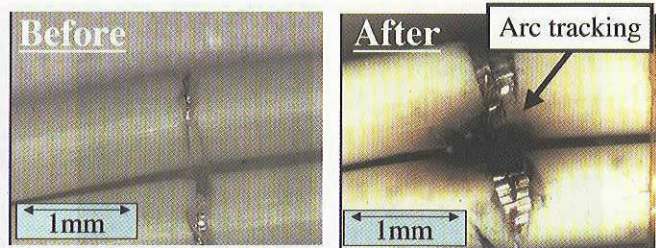
Fig. 13 The waveform of the secondary arc at the temperature of 160°C .

A secondary arc was observed at a temperature of 160°C . A very short duration ($\sim 1\mu\text{s}$) trigger discharge current flowed into the cables. The peak current was about 50A. The voltage of V_1 fell after several trigger discharges and the discharge current rose rapidly. The measured discharge voltage of the secondary arc was 30V. This secondary arc was sustained for more than 1.5 ms. A microscope photograph of the cracked cable before and

after the test is provided in Fig. 13. Formation of arc tracking on the cable insulator was observed near the cracks. This tracking had an electrical resistance of about $20\text{ M}\Omega$. The arc tracking formation was limited at the points where it adjoined each crack.

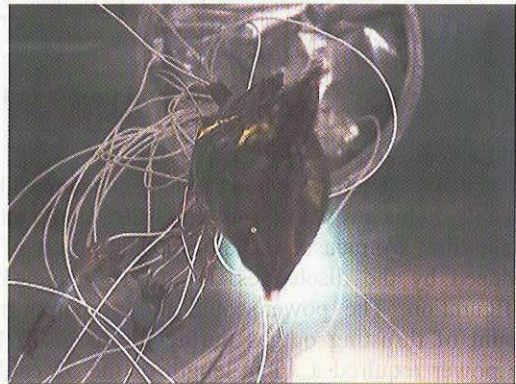
Fig. 14 Plasma from the hole of the MLI destroyed by ESD.

We next investigated the effect of damage by a sustained arc of an electrical cable with cracks to the cables without cracks in order to verify hypothesis (5). The sample was composed of one cable pair with cracks and nine cable pairs without cracks. An external high-voltage bias was supplied to the MLI film. The temperature of the film was controlled by a heater. Trigger arcs occurred between the cables and the film when more than -1kV was applied to the blanket. A sustained arc occurred after several trigger arcs. The heat from the sustained arc greatly affected the electrical power cables surrounding the cables with cracks. Figure 13 presents a photograph of the sample during the sustained arc. Plasma generated from the cables spouted out of the sample. This plasma accelerated the sample.

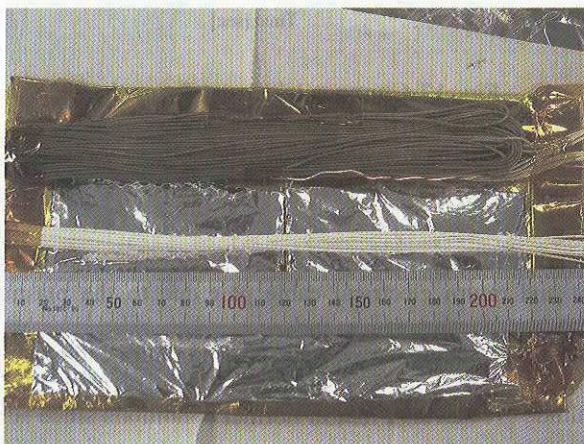
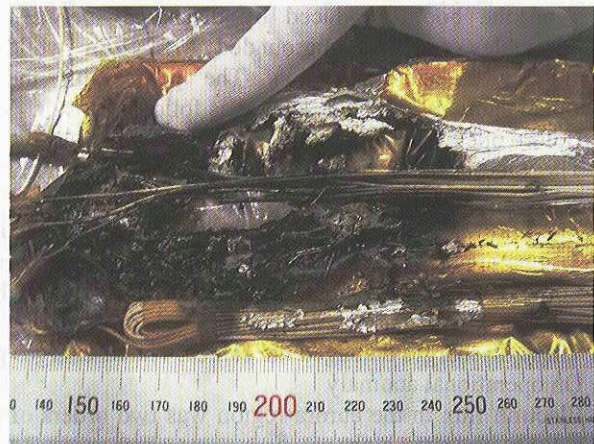
Fig. 15 Pictures of the electrical power cables (a) before and (b) after the effect of damage by a sustained arc of the cables with cracks to the cables without cracks.

Photographs of the cables wrapped with the MLI before and after the experiment are provided in Fig. 15. This figure indicates the immense damage to the cables by the sustained arcs. Consequently, all electrical power cables were shorted or opened. This phenomenon is in good agreement with the degradation of the electrical power generation of the ADEOS-II satellite.

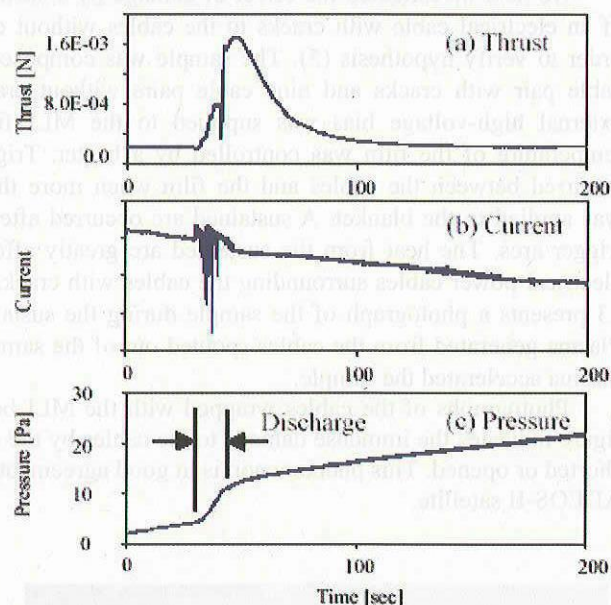
Fig. 17 Changes in thrust from the hole of the orifice and the chamber pressure during discharging of the cables.

Gas was generated when discharges occurred between the cables. This gas would cause a change in the attitude of the satellite. We measured the propellant power of the gas produced by the discharges. Figure 16 depicts the test configuration. The power could be estimated from the amount of thrusting outgas during discharge in Fig. 17. The power required a 10 m length of the 52 cable pairs, which corresponds to the number of electrical cables wrapped in the bundle on the boom. This value was almost the same as the length of the cables on the boom of the ADEOS-II satellite. Therefore, these results can explain the phenomenon.
