Destruction Test of Small Scaled Solid Propellant Motors

Motoki HINADA, Ryojiro AKIBA, Teruo KISHI,
Yasunori MATOGAWA and Shigeki TSUKAMOTO

(July 10, 1986)

Summary: Destruction tests have been carried out on the ground by using three small scaled motors of solid propellant with a pair of destruction devices of V-shaped charge type. Each motor has the size of about 1/10 of the rear segment of one third of the 1st stage of Mu-3C that is a three staged and all solid propellant satellite launcher, developed by ISAS. Destruction devices in these tests are roughly the same in function and installation as those for Mu-3C. Several interesting results have been obtained on breakup characteristics of motor, such as mode of destruction, shapes of fragments of propellant and hardware, scattering distribution of them, shock load undergone by motor and surrounding overpressure. These results are expected to be useful for prediction of breakup characteristics of Mu-3C due to V-shaped charges.

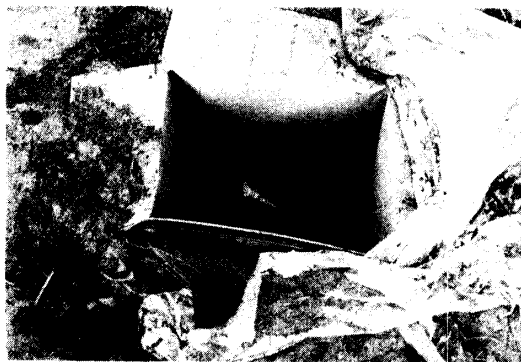
Fig. 6. Setting method of microphone.

Overpressure of shock wave and intensity of sound wave in the surroundings of testing motor have been measured with three pressure transducers of semi-conductor type and four high sensible microphones of conductance type, respectively. These sensors are placed at the distance of 10–75 m from the stand, as shown in Fig. 3. Pressure transducers labeled as P1, P2 and P3 are at rather nearer sites to the stand, and these are to measure static overpressure of shock wave produced by destruction of motor. Microphones labeled as I1, I2, I3 and I4 are at rather far distance from the stand, and these are to measure intensity of sound wave due to motor destruction. Each microphone is set in a box (30×40×30 cm) which is buried in the ground with its upper side open, and this setting method is shown in Fig. 6.

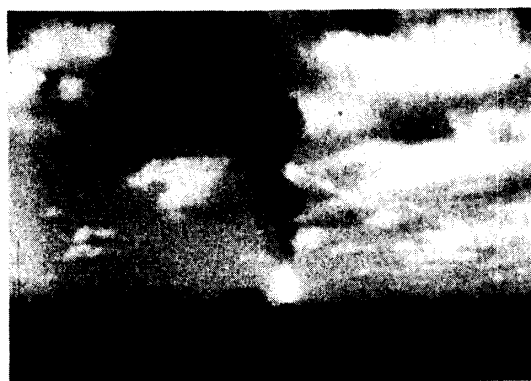
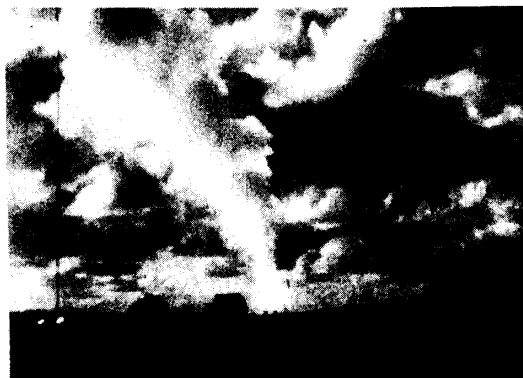
(a) No. 0 frame, just before destruction

(b) No. 628 frame

(c) No. 872 frame

Fig. 13. Pictures taken by camera C3 with driving speed of 1000 frames/sec, for 3rd test.

On the other hand, films of cameras C3 and C4 have made clear the thrown-out aspect of fragments of relatively large size. Some examples are presented in Fig. 13. Tracing these fragments gives that maximum value of the initial thrown-out velocity of them is approximately equal to 200 m/sec.

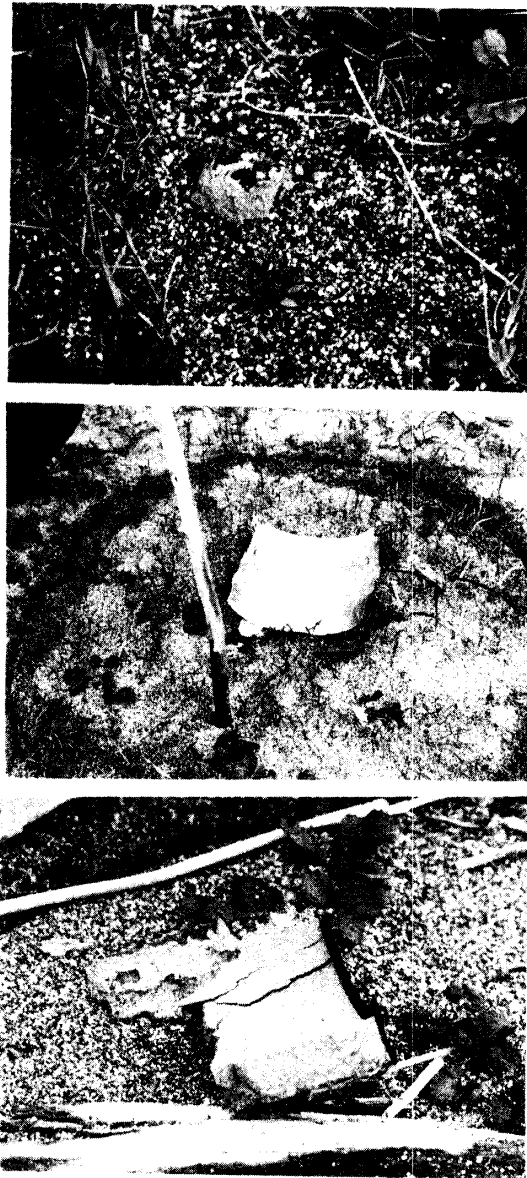
Fig. 16. Some pictures of recovered fragments.

After each test, laborious and eager efforts have been made to recover fragments scattered in the surrounding wide field around the destruction point. For the first test, the following pieces have been found, that is, the end plate on the upper side of motor, two large pieces of cylindrical case, and seven small fragments of cylindrical case and destruction devices. The end plate, as it was, has fallen just near the stand. The two large pieces, which have the size of about a half of the original cylindrical case and can mostly reproduce it's original shape by themselves, have fallen at some places which are at the distance of about 10 m from the stand and on both sides of a line passing through a pair of destruction devices. Seven small fragments have been scattered within the distance of 20 m from the stand. The scattering aspects of metallic pieces for the second and third tests have been almost the same as the one for the first test. For the second and third tests, besides metallic pieces, many small fragments of propellant and restrictor have been recovered. Scattering aspect of fragments for the second test and that for the third test are presented in Figs. 14 and 15, respectively, which do not include end plate and two large pieces of cylindrical case. As found from Figs. 14 and 15, small fragments have been scattered widely, within the distance of 80 m from the stand. Some examples of recovered fragments are shown in Fig. 16.
