#### On-orbit Power Fluctuations of ADEOS-II

#### **ABSTRACT**

Since ADEOS-II was launched, JAXA has analyzed on-orbit telemetry routinely in order to verify design and to find any sign of anomaly or degradation. One of the findings is generation power fluctuation of solar array paddle. We have investigated mechanisms of the power fluctuation and reached a scenario, space debris impact on solar cell. The impact might cause short circuit in solar array paddle and drop generation current. To confirm the scenario, we carried out hypervelocity impact tests to the solar array blankets. The investigation and test result are reported in this paper.

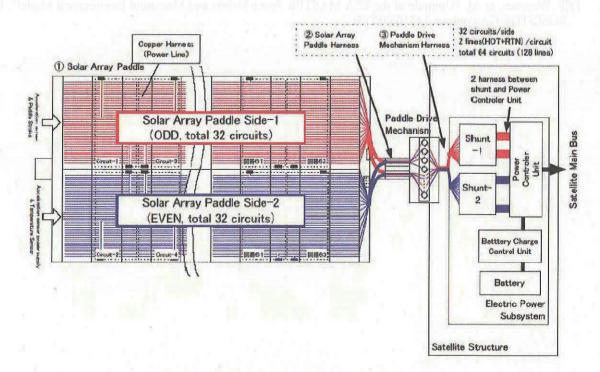
Figure 1 Block diagram of power system

Power system consists of 2 units, called side-1 and 2, each unit has 32 array circuits and shunt circuits. Current telemetry can be monitored at PCU and Shunt. Generation power is calculated by summation of PCU current and shunt current. Block diagram of Power system is illustrated in Figure 1.
