Investigation of an Operational Anomaly of the ADEOS-II Satellite

The ADEOS-II satellite experienced anomalous operation on October 25, 2003. The power generated on the satellite suddenly decreased from 6 kW to 1 kW. We conducted experiments to investigate this degradation of power for the satellite. The multi-layer insulator film that wraps the power cables was charged by low-energy electrons when the satellite passed through the aurora region around the Earth's pole. ESD tests were carried out for the power cables. Trigger arc discharges occurred between the film and cables with cracks produced by thermal cycles. A secondary arc electric discharge subsequently occurred between the cables themselves. This secondary arc caused a sustained arc after several discharges, which burned out the cables. The heat caused by arc tracking between the hot and return cables made them burn out. This was the mechanism of the operational anomaly on the ADEOS-II satellite.

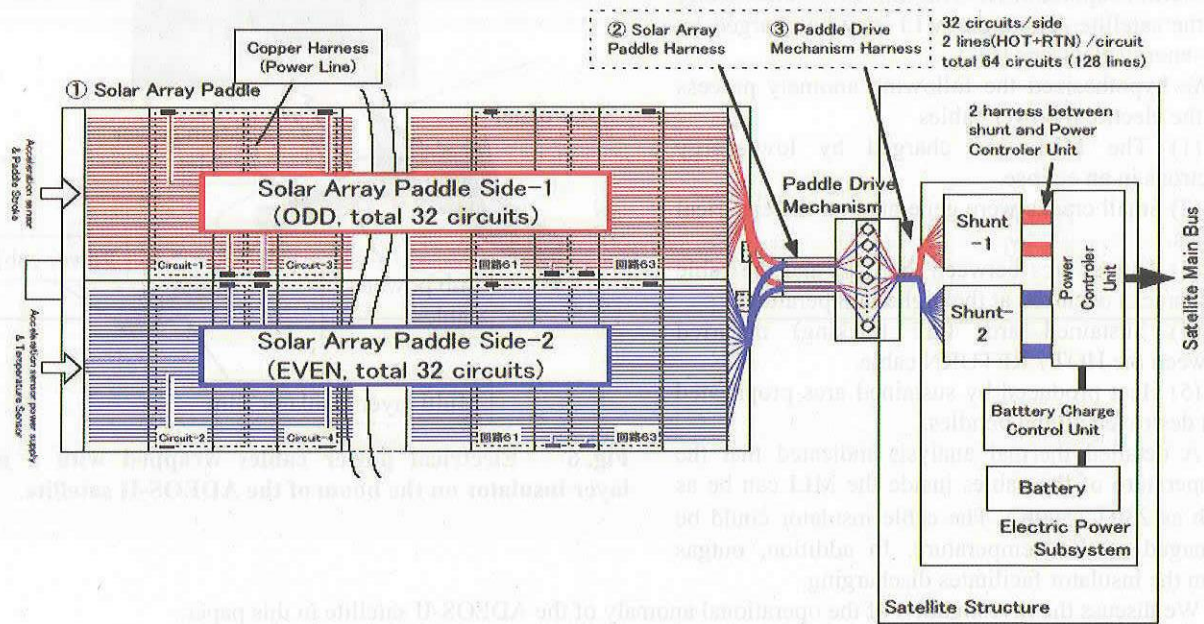
Fig. 4 A Function diagram of PDL and EPS of the ADEOS-II satellite.

Figure 4 contains a function diagram of the solar panel and electrical power unit of the ADEOS-II satellite. The solar panel is composed of 64 solar arrays. The electrical power of one solar array is 60V and 2A. The power is transmitted through two electrical power bundles, the paddle driving mechanism (PDM), and two shunt components to the power control unit (PCU). The total power can be estimated from the sum of the currents of SHNT-1, SHNT-2, and the PCU.

The currents of SHNT-1 and SHNT-2 decreased at about the 2A step in Fig. 3. The input current of the PCU did not change when the current of the SHNTs decreased. However, the current of the PCU began to decrease when the current of the SHNTs was 0A. The degradation of BUS voltage at 16:16 suggests the discharge of the satellite batteries. The results clearly indicate that the PCU operated normally during degradation of the electric power.

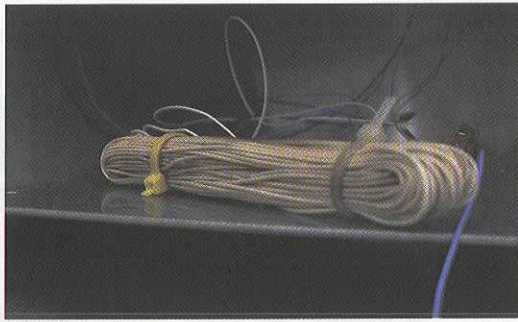
(a) Sample in the chamber before test

We conducted a thermal cycle test for the electrical power cables to evaluate the generation of cracks on the cable. The cable bundle was set in a vacuum chamber. The temperature of the bundle was controlled to between 100°C and 230°C. This thermal condition was estimated from the thermal analysis for the electrical cables of the satellite in space. The test configuration is illustrated in Fig. 8 (a).

Cracks were generated on the cables after about 5000 thermal cycles. Figure 8 (b) depicts the cracked cables after

the thermal cycle test. The cracks were produced at the sticking point between the cables caused by thermal stress.

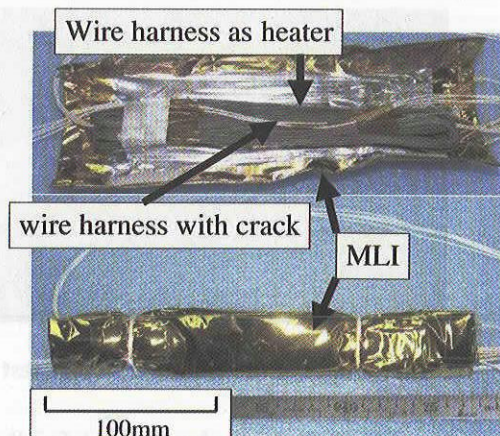
Fig. 10 A test sample which imitates electrical power cables on the boom

The discharge voltage between the cracked cables and the MLI film was measured first. This voltage depended on the temperature in the MLI film, since the pressure in the film increased with increases in the temperature. Figure 10 provides a photograph of the sample. We could apply high voltage to the innermost layer of the MLI through the attached cables. A bundled cable was attached as a heater on the innermost layer of the film. This cable had previously

undergone a high temperature heat cycle. These cables simulated the cables of the ADEOS-II satellite with crack damage due to high-temperature heat cycles. There were three pairs of cracks on the cable. All the cables used in these tests were equivalent to the electrical power cables of the satellite. Thermocouples were also attached on the surface of the cable insulator and the film's outer surface. Each end of the wrapped film was tightly bundled by binding wire.

We first examined the possibility of pressure increments in the MLI film by observing outgas from the cables in the film. The primary component was ethylene (CH_2), which is the main chain of an ethylene tetrafluoroethylene copolymer ($\text{ETFE}:-[\text{CH}_2-\text{CH}_2]_m-[\text{CF}_2-\text{CF}_2]_n-$). This is the major element of the cable insulator. Our result indicated that the cable insulator deteriorated and evaporated at a high temperature. Therefore, the internal pressure of the MLI increased when a large current flowed to the cables due to vaporization of the cable insulator and their own low conductance.

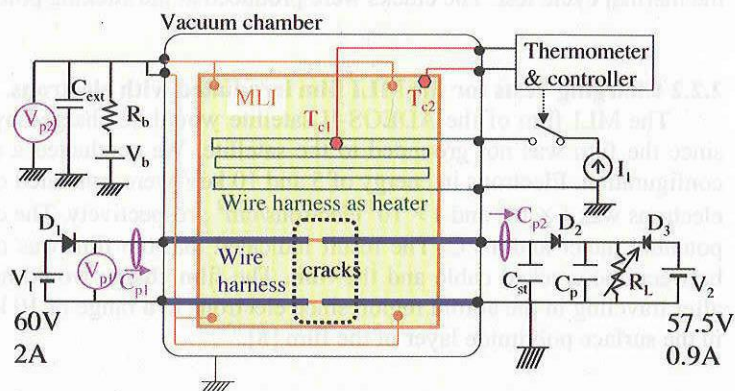
Fig. 11 A schematic drawing of discharge test.

We will next explain the results of the discharge test. Figure 11

depicts the experimental set-up. The following two points differed from the above test configuration. The inner surface of the MLI film was biased negatively via a high-voltage power supply, and a cracked cable pair was connected to the external circuit containing a Solar Array Simulator (SAS), which was a DC electrical power supply. The SAS can rapidly respond for switching, because the internal capacitance is less than 50 nF. Thus, the SAS is a suitable for discharge tests. The MLI film's inner surface and capacitance (C_{ext}) were gradually charged by a high-voltage power supply via a limiting resistance of $5\text{G}\Omega$. The value of C_{ext} was 4.4nF, which was determined to be the capacitance between the film and the cables of the ADEOS-II satellite. An electrostatic voltmeter was utilized as a high-voltage probe (V_{p2}) for surface potential measurement. A voltage probe with very high input impedance was required to apply the high voltage.

We will now explain the occurrence of a trigger arc discharge between the cracked cable pair and the biased MLI film. The test procedure was as follows. i) Set the temperature. ii) Turn on the high-voltage power supply, for which the set voltage was -2 to 3kV. iii) Record the voltage and pressure when discharge occurs. iv) Return to i). Both SASs were turned off during this examination. Figure 12 illustrates the relationship of the threshold voltage of the trigger discharge and the film's internal pressure with changes in the surface temperature. We confirmed that the threshold voltage of the trigger discharge became lower with increases in the internal pressure of the MLI, as described above. The threshold voltage at 230°C was -1.0 to 1.5kV, which is a reasonable potential for the film when charged by low-energy electrons in orbit.

We next report the occurrence of a secondary arc, which was a sustained arc, its discharge triggered by the discharge between the negatively biased MLI film and cracks in the cable. The external circuit consisted of SASs (V_1 , V_2), diodes ($D_1 \sim D_3$), capacitances (C_{st} , C_p), variable resistance (R_L), and probes. This circuit simulates the actual solar array behavior. The capacitance between each string was C_{st} . The capacitance simulated by the satellite PCU was C_p . The respective capacitance values were 120nF and 18,000 μF . Both V_1 and V_2 simulated the voltage of one solar array and provided electrical power to the satellite load (R_L) and PCU (C_p). A potential difference of 60V was applied between each cable by V_1 . The voltage of V_1 falls once a secondary arc occurs, and the blocking diode (D_2) acts as a

switch that momentarily disconnects current to R_L and changes the current path to an arc discharge. A secondary arc was observed from the measured waveform of the inserted probes.

A secondary arc was observed at a temperature of 160°C . A very short duration ($\sim 1\mu\text{s}$) trigger discharge current flowed into the cables. The peak current was about 50A. The voltage of V_1 fell after several trigger discharges and the discharge current rose rapidly. The measured discharge voltage of the secondary arc was 30V. This secondary arc was sustained for more than 1.5 ms. A microscope photograph of the cracked cable before and

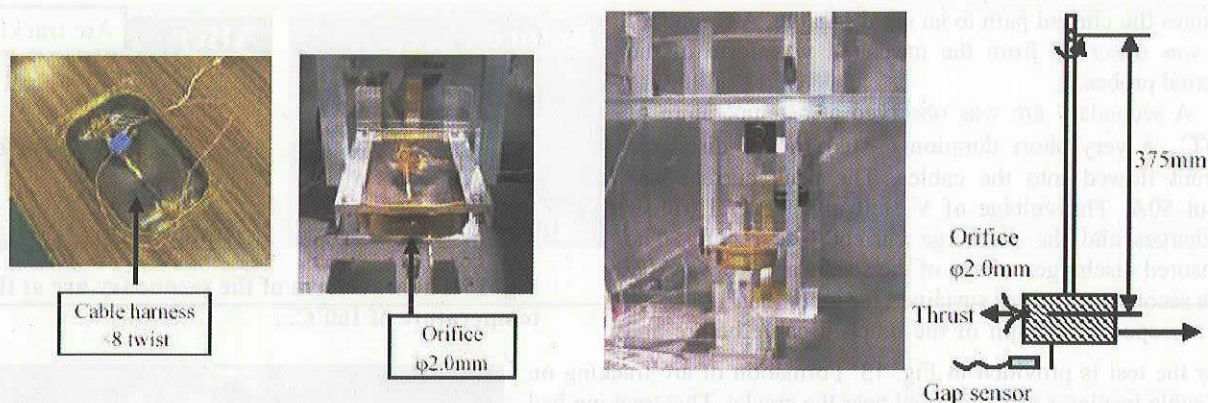
Fig.16 Propellant power test generated by outgases from discharging cables.

The attitude of the ADEOS-II satellite changed during the operational anomaly. The amount of torque and the point of action were calculated from the flight data. The point of action was the boom between the solar panel and the

satellite body, and the impulse was 4.9 Ns.

Gas was generated when discharges occurred between the cables. This gas would cause a change in the attitude of the satellite. We measured the propellant power of the gas produced by the discharges. Figure 16 depicts the test configuration. The power could be estimated from the amount of thrusting outgas during discharge in Fig. 17. The power required a 10 m length of the 52 cable pairs, which corresponds to the number of electrical cables wrapped in the bundle on the boom. This value was almost the same as the length of the cables on the boom of the ADEOS-II satellite. Therefore, these results can explain the phenomenon.
