Ultrasonic Testing Method for Detection of Planar Flaws in Graphite Material*¹

An ultrasonic inspection method for a graphite ingot was developed to detect internal planar flaws that are oriented in various directions; this method is necessary to perform quality assurance of throat inserts of solid rocket motors. Major problems that are unique to this graphite inspection were solved. An ultrasonic beam in graphite shows uneven propagation behavior both within and among individual ingots. That individual unevenness engenders variation in echo heights of flat-bottomed holes, which can be compensated through two-dimensional scanning accompanying a change in incident angles of two directions. This scanning procedure is therefore necessary to detect internal planar flaws that orient in various directions. The unevenness among ingots can be compensated by measuring the wave velocity and attenuation coefficient in the test block itself before inspection. A test block including artificial internal flaws was fabricated and inspected using the developed method. It was then sliced into several thin disks. The sliced disks were inspected using the conventional ultrasonic testing method using

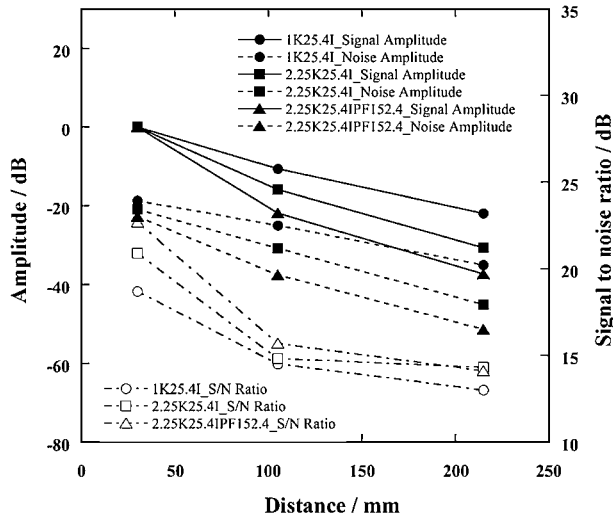
Fig. 1 Distance-amplitude curves for 2-mm-diameter flat-bottomed holes, the corresponding noise, and their signal-to-noise ratios.

Figure 1 shows distance-amplitude curves for flat-bottomed holes of 2 mm diameter, the corresponding noise, and their signal to noise ratios measured by the three probes. Here the flaw echo heights of the 25 mm beam path are adjusted to 0 dB.

The echo heights of long beam paths are in the order of 1K25.4I > 2.25K25.4I > 2.25K25.4IPF152.4, but the S/N ratios of long beam paths are differently ordered as

2.25K25.4I > 2.25K25.4IPF152.4 > 1K25.4I. For that reason, probe 2.25K25.4I was selected as the probe that offers both high sensitivity and a high S/N ratio, with better resolution. This probe was used in all tests conducted in this study. The FFT analysis of echoes indicated that the center frequency was reduced to less than 1.7 MHz if the beam path was longer than 10 mm in the test block.

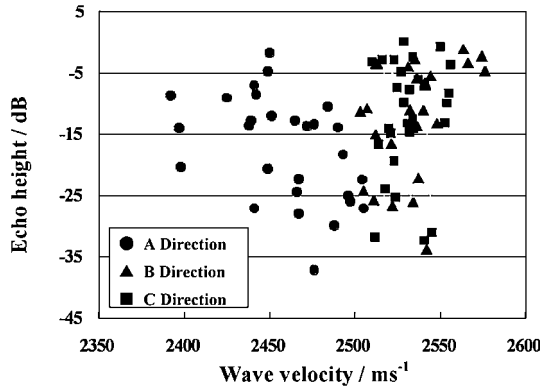
Figure 3 shows the relationship between the echo height of 2-mm-diameter flat-bottomed holes of normal incidence and wave velocity in the machined cuboidal blocks of 45–402 mm thickness. Here, the ultrasonic propagation direction is arranged in three independent orthogonal directions: A, B and C. Direction A is the vertical direction during ingot production; directions B and C are horizontal directions that are orthogonal to each other. The wave velocity is calculated from the beam path and the propagation time. No correlation was found between the echo height and the velocity in any direction of A, B and C, but the data spread to a certain degree. The velocities in B or C varied from 2510 to 2580 m/s, whereas those scattered more in A: 2400–2510 m/s. This fact suggests the creation of only slight anisotropy between vertical (gravity) and horizontal directions during the ingot production process.

Fig. 3 Relationship between echo height of 2-mm-diameter flat-bottomed holes and wave velocity in three directions: A, B and C.

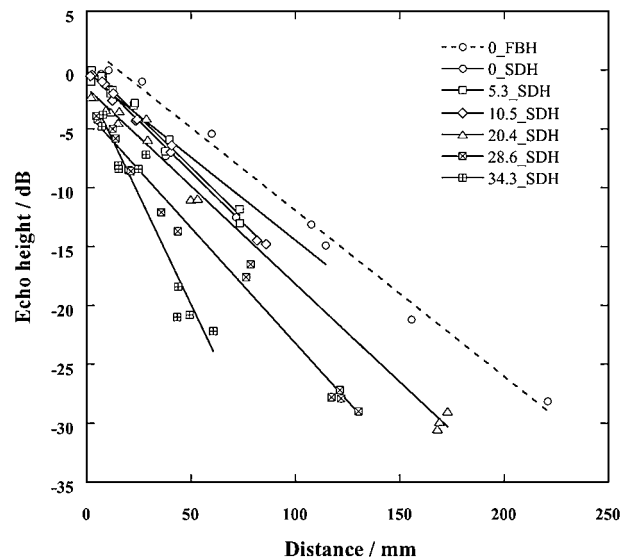
Figure 6 shows a distance-amplitude curve for 3-mm-diameter flat-bottomed holes of flat-surface normal incidence (0_FBH) and curves for 2-mm side-drilled holes of curved-surface incidence and various incident angles (0—34.3_SDH). The numerical notations of 0 to 34.3 indicate the angles of incidence in degrees. The literal notations FBH and SDH respectively indicate the reflectors: a 3-mm-diameter flat-bottomed hole and a 2-mm-diameter side-drilled hole. To obtain the maximum echo height, the flat-bottomed holes are detected using two-axis swivel scanning. The side-drilled holes are detected using linear scanning in the hole-axis direction.

Fig. 6 Distance-amplitude curve for 3-mm-diameter flat-bottomed holes of flat-surface normal incidence (0_FBH) and curves for 2 mm side-drilled holes of curved-surface incidence and various incident angles (0—34.3_SDH).

Because Fig. 6 indicates a large attenuation of -30 dB at the 250 mm beam path for flat-bottomed holes of normal incidence, the flaw detector is required to have a distance-amplitude compensation capability that is larger than 30 dB. In distance-amplitude characteristics of various incident angle, there was no great difference up to 20° of incident angle, but a substantial drop of echo height was apparent at 28.6° and 34.3° because a larger incident angle engenders less transmittance of sound pressure and a smaller apparent dimension of transducer. The resultant wider beam spread brings larger sound-pressure drop. Consequently, results show that respective distance-amplitude compensations are necessary for varying an incident angle.

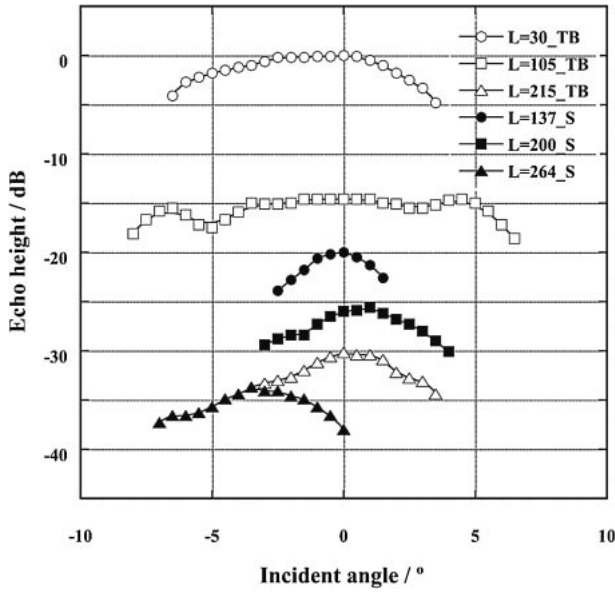
Figure 7 shows echo-height profiles of 3-mm-diameter flat-bottomed holes for various incident angles (i_1 in Fig. 5(b)) in case of top/bottom-surface incidence. Figure 7 also shows profiles of 2-mm-diameter side-drilled holes for various incident angles (calculated from the offset distance o_{ff} in Fig. 5(c)) for side-surface incidence. The numerical notations of 30—264 indicate beam paths in millimeters. The literal notations TB and S respectively indicate top/bottom-surface (flat-surface) incidence and side-surface (curved-surface) incidence. The echo-height dependence is evaluated by finding the incident-angle range within which the attenuation is less than the specified level (3 dB).

Fig. 7 Echo-height profiles along an incident angle: (a) those of 3-mm-diameter flat-bottomed holes in case of top/bottom-surface incidence (.TB), and (b) those of 2-mm-diameter side-drilled in case of side-surface incidence (.S).

The obtained incident-angle range is smaller for side-surface incidence than for top/bottom-surface incidence. It is attributed to a lens effect of a curved incident surface in the case of side-surface incidence. The obtained incident-angle range also shows fluctuation depending on beam paths, though in far field in homogeneous material, the beam spread should be constant independently from beam paths; it is attributed to a local variation of echo height mentioned in section 2.2 4). Therefore the minimum value among the obtained ranges of each surface incidence is employed to determine the pitch of the incident-angle change.

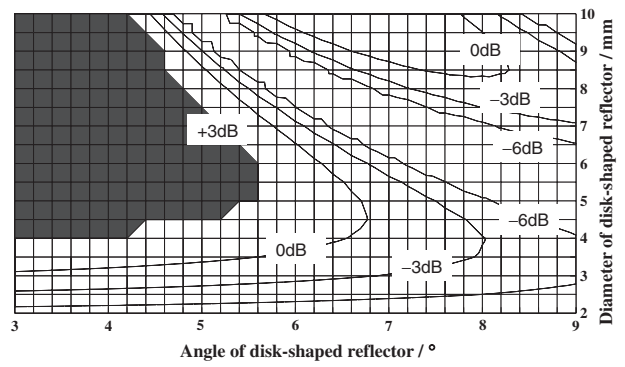
Fig. 8 Contour map of the relative echo height P_F^α/P_R^0 calculated using eq. (3), on the tilt angle and diameter of a disk-type flaw.

Figure 8 shows a contour map of the relative echo height obtained using eq. (3) when $2a_0 = 3$ mm and $2a = 3$ to 10 mm. Here, the frequency is set as 1.7 MHz, the velocity in graphite is 2400 m/s, and the velocity in water is 1450 m/s. If the flaw is vertical ($\alpha = 0^\circ$), the relative echo height P_F^α/P_R^0 increases with increased flaw size; however, if the flaw size is constant, it decreases slowly with an initial increase in the tilt angle, decreases steeply at a certain value of the tilt angle, and then fluctuates along with a further increase in the tilt angle. The tilt angle for the steep decrease in the echo height becomes smaller when the flaw size becomes larger. For example, the tilt angle at which P_F^α/P_R^0 decreases below -3 dB is 6.9° for a 3-mm-diameter flaw and 4.6° for a 10-mm-diameter flaw.

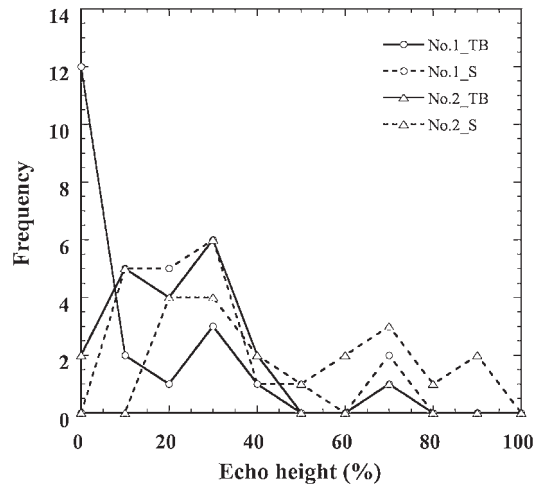
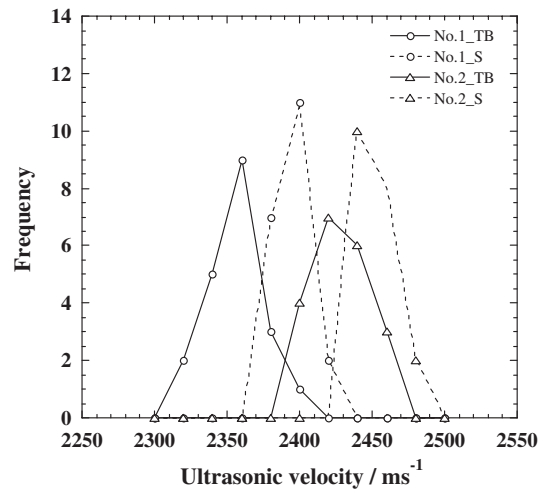
Fig. 9 Frequency distributions of (a) echo height and (b) wave velocity in the case of top/bottom-surface incidence (.TB) and side-surface incidence (.S) in two test blocks (Nos. 1 and 2).

Figure 9 shows measured results of (a) the frequency distribution of echo height and (b) the wave velocity distribution. The literal notation TB indicates flat top/bottom-surface incidence and S indicates curved side-surface incidence. Figure 9(a) shows that the echo height varied substantially.

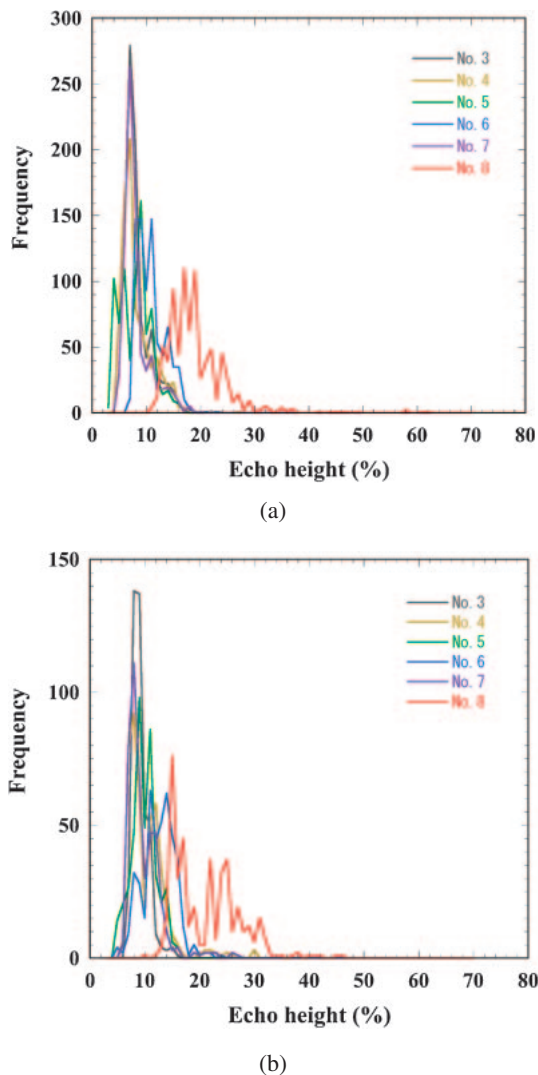
Figure 10 shows the echo height distribution of six cylindrical test blocks of 225 mm diameter and 220 mm

Fig. 10 Frequency distributions of echo height of top/bottom-surface incidence (a) and side-surface incidence (b) in six test blocks.

height, obtained by (a) flat top/bottom-surface incidence and (b) curved side-surface incidence. Each of these echo heights is the maximum echo height obtained by one-rotation detection (R -scanning) for every (i_1, i_2) angle setting at an X position of Fig. 5(b), or the maximum echo height obtained by one-rotation detection (R -scanning) for every (i_1, o_{ff}) angle and offset setting at a Z position of Fig. 5(c). No echo greater than 80% was detected in any test block when all the compensations described in §3.5 were added to the specified sensitivity with which the echo height of 3-mm-diameter flat-bottomed hole became 80%. As shown in Fig. 10, however, the upper limit of the echo height distribution differs from lot to lot in a range of 10–25%, though microstructural observation has not revealed any difference among the lots. The cause of the difference in the echo height distribution would be investigated in future.
