ESD Test on High Voltage Solar Array of LEO Spacecraft

Feng Weiquan Beijing Institute of Spacecraft Environment Engineering Chinese Academy of Space Technology

Chinese Academy of Space Technology (CAST) is now developing LEO spacecraft with high voltage array. This paper describe ESD tests of solar array coupon in CAST/BISEE. Tests are: -primary discharge threshold test, -primary discharge degradation test, -secondary discharge threshold test, -power leakage to plasma test. The test methods are based on ISO11221 standard which proved very helpful to perform these ESD tests.

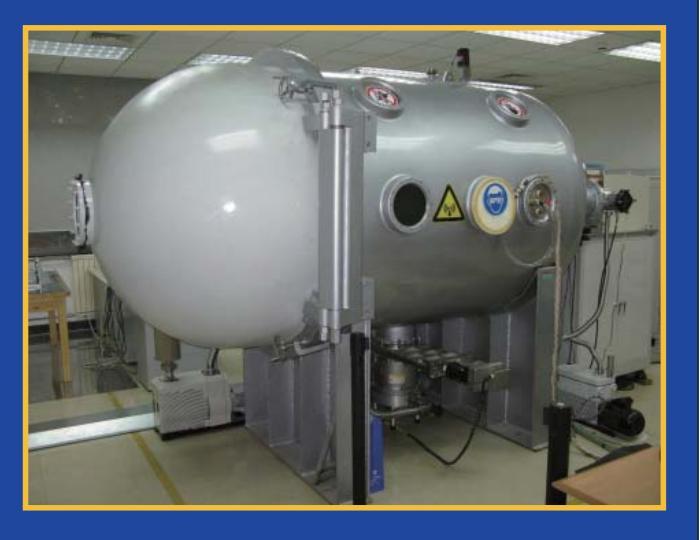
2 Test Facility

- Diameter: 1.5m, Length: 3m
- ECR plasma source
- Plasma temperature :~10eV, density: 10^{10} ~ 10^{13} /m³
- DC power supply
- Video imaging device
- Plasma diagnostic device
- Digital Oscilloscope

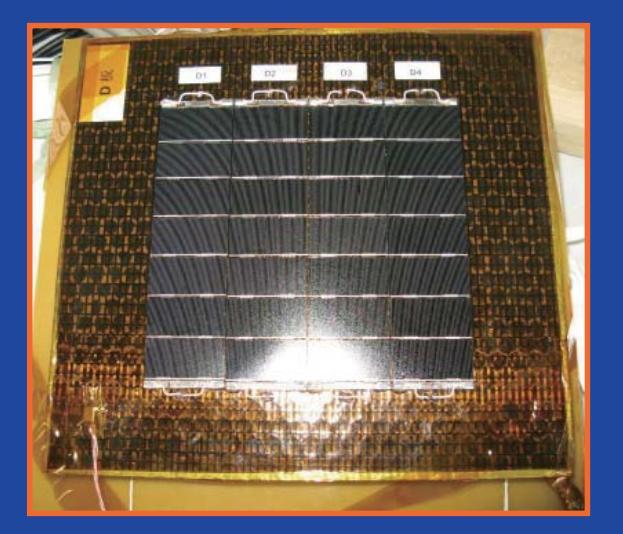
a) Primary discharge threshold test

- Test coupons:
 - Silicon solar cells
 - 4s7p
 - Gap distance: 1mm

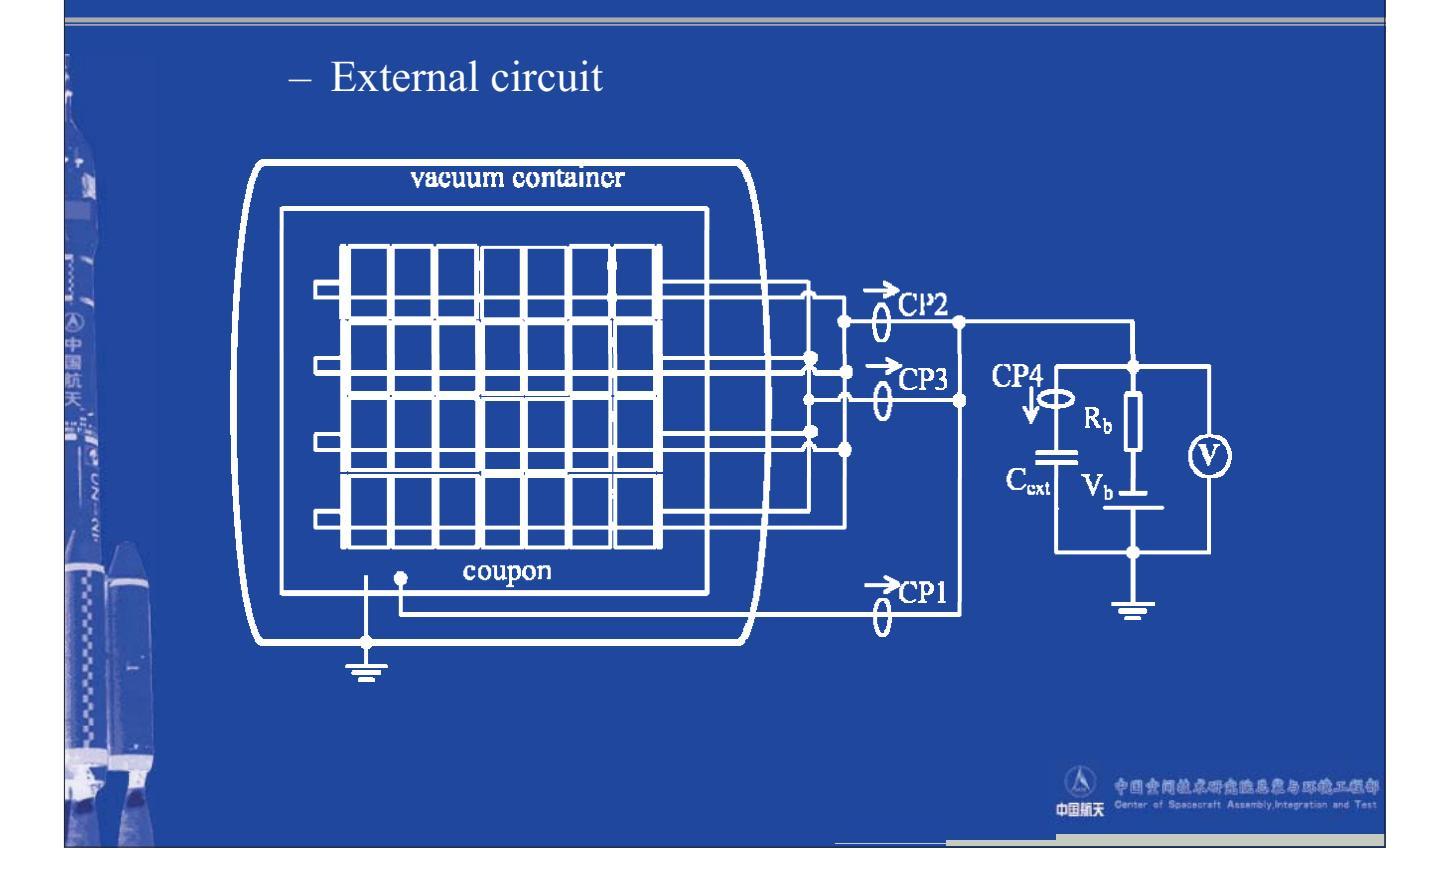
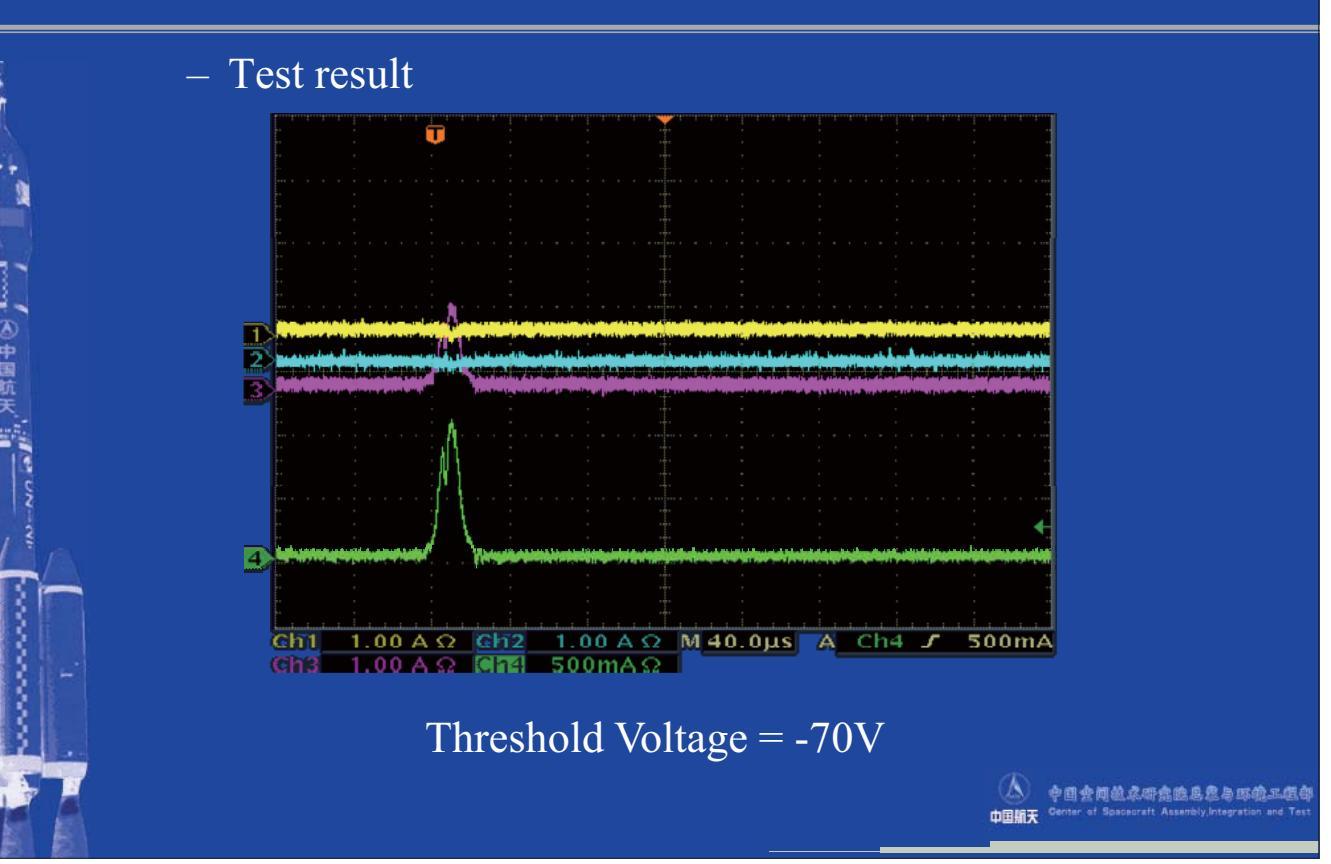
- Test conditions

Density N _i	Temperature kT _e
$6.7 \times 10^{12} \mathrm{m}^{-3}$	7.5eV

C _{ext}	Bias Voltage V _b	R _b
200nF	$0\mathrm{V}{\sim}$ -200V	$10 \mathrm{k}\Omega$

Step Voltage	Waiting time
-5V	30min

1) Primary discharge threshold for the coupon is about -70Volt;

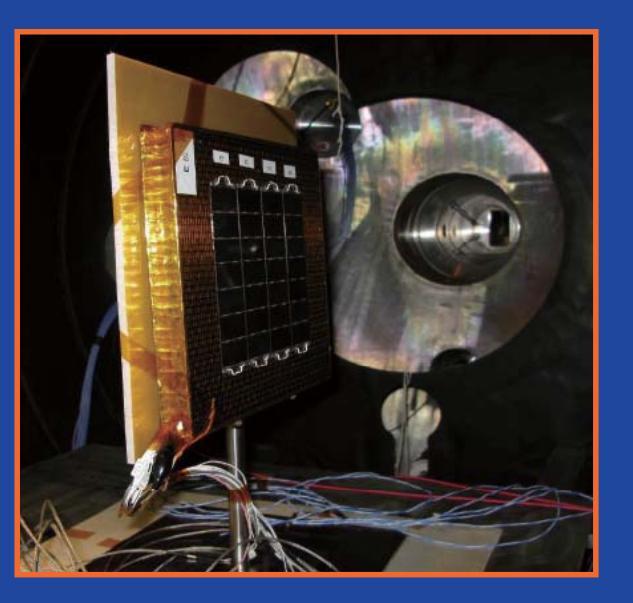
b) Primary discharge degradation test

- Test coupons:
 - Silicon solar cells
 - 4s7p
 - Gap distance: 1mm

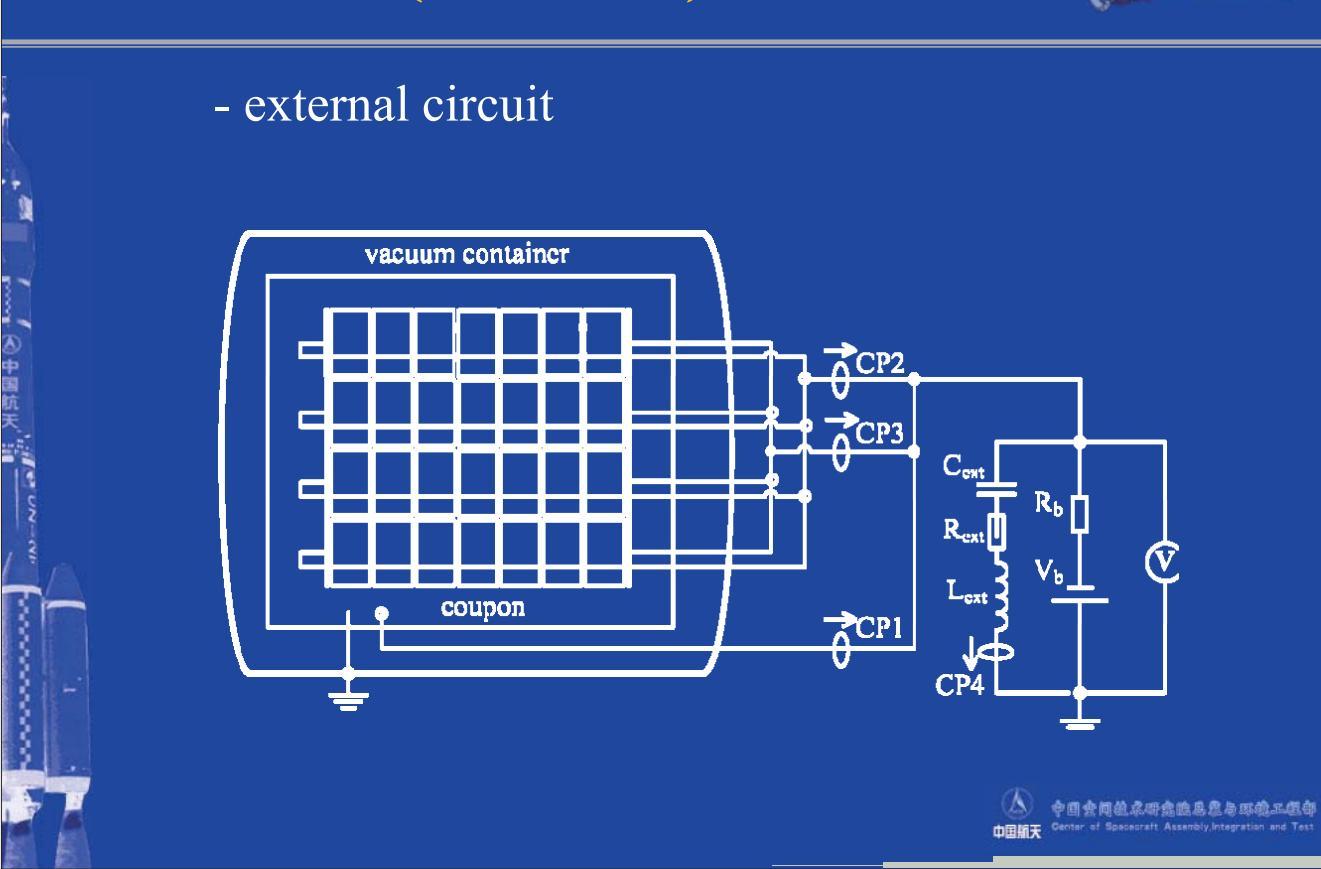
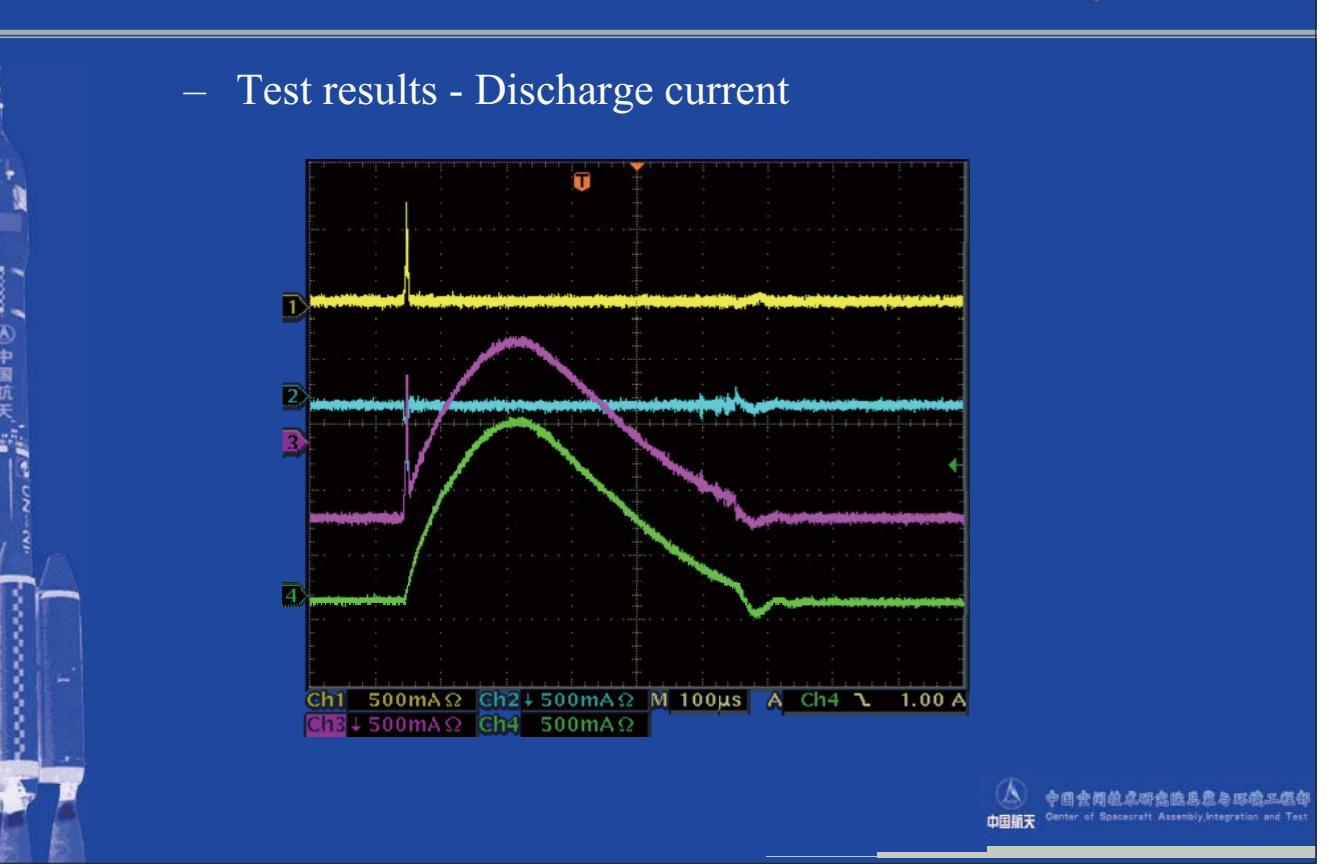
Density N _i	Temperature kT _e
$6.7 \times 10^{12} \mathrm{m}^{-3}$	7.5eV

C _{ext}	R _{ext}	L _{ext}	V _b	R _b
2μF	94Ω	8mH	-200V	$10 \mathrm{k}\Omega$

Total numbers of PA	I-V measurement rate
200	Once/10 events

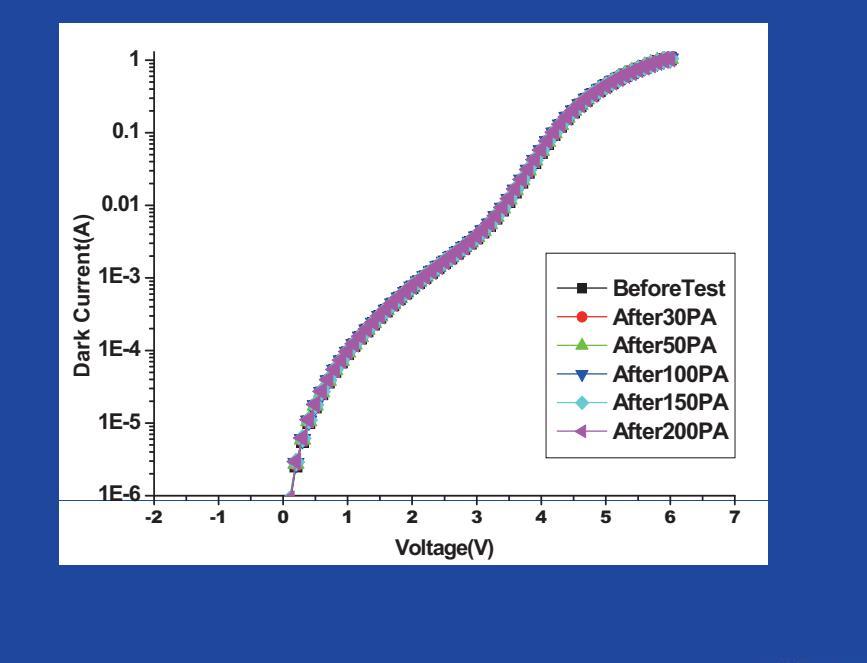
- Test result-Degradation

2) Primary discharge degradation is very small, undetected;

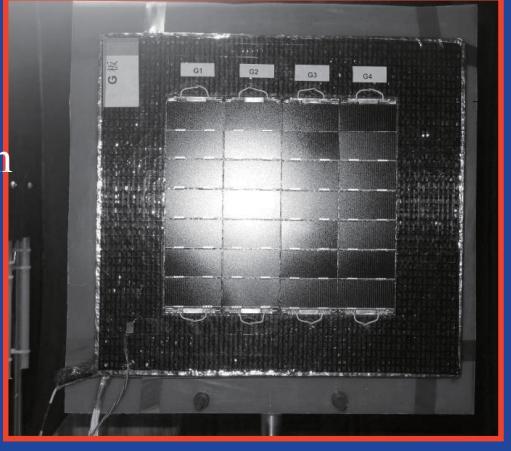
c) Secondary discharge threshold test

Test coupons:

- Silicon solar cells
- 4s7p
- Gap distance: 1mm/ 1.5mm
- grouting-1mm
- no grouting- 1mm
- no grouting- 1.5mm

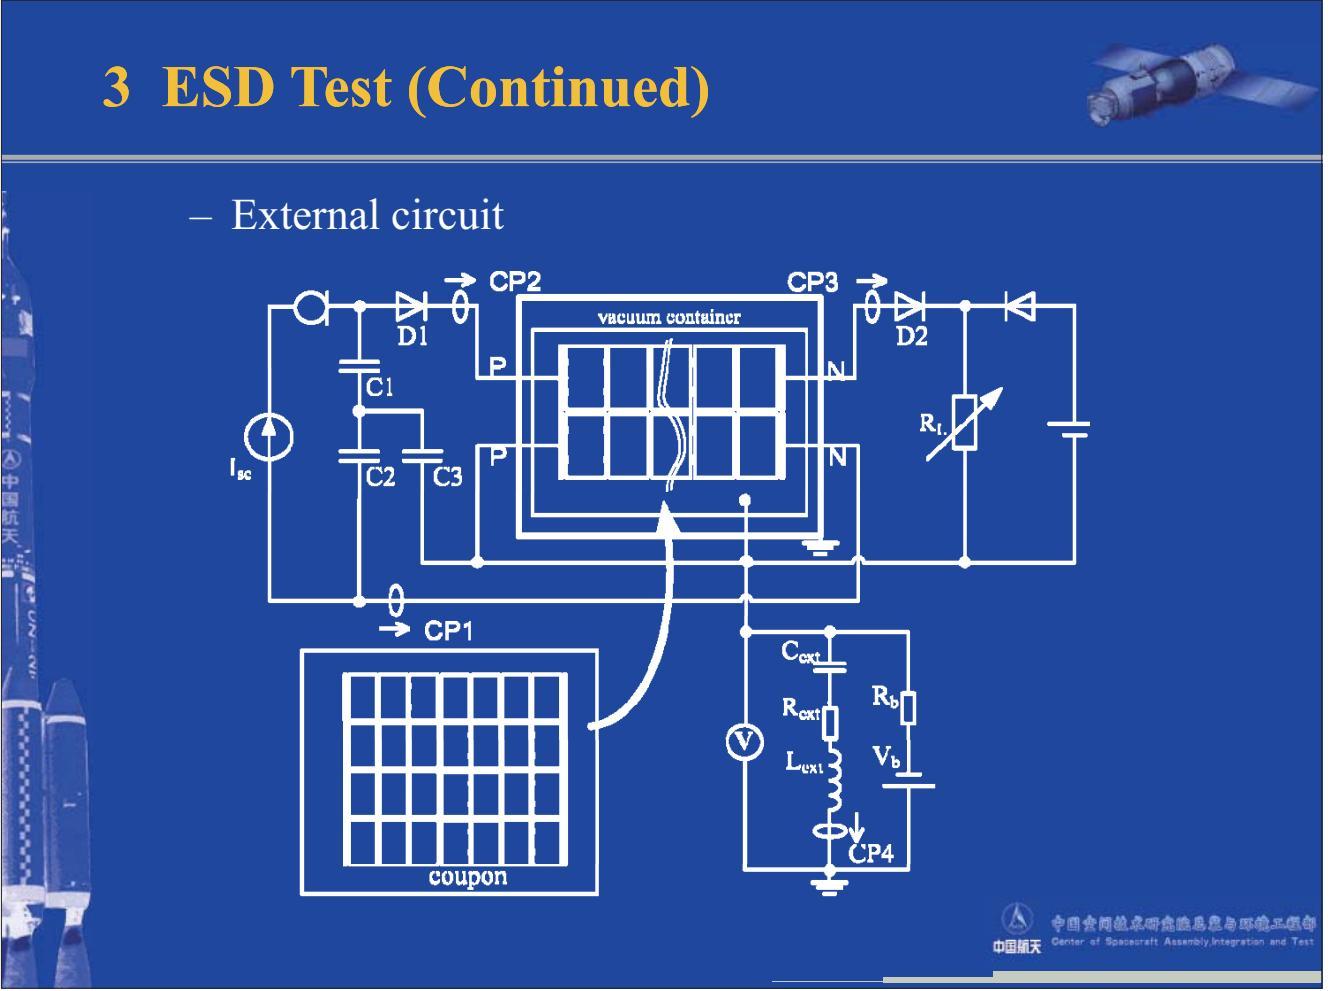
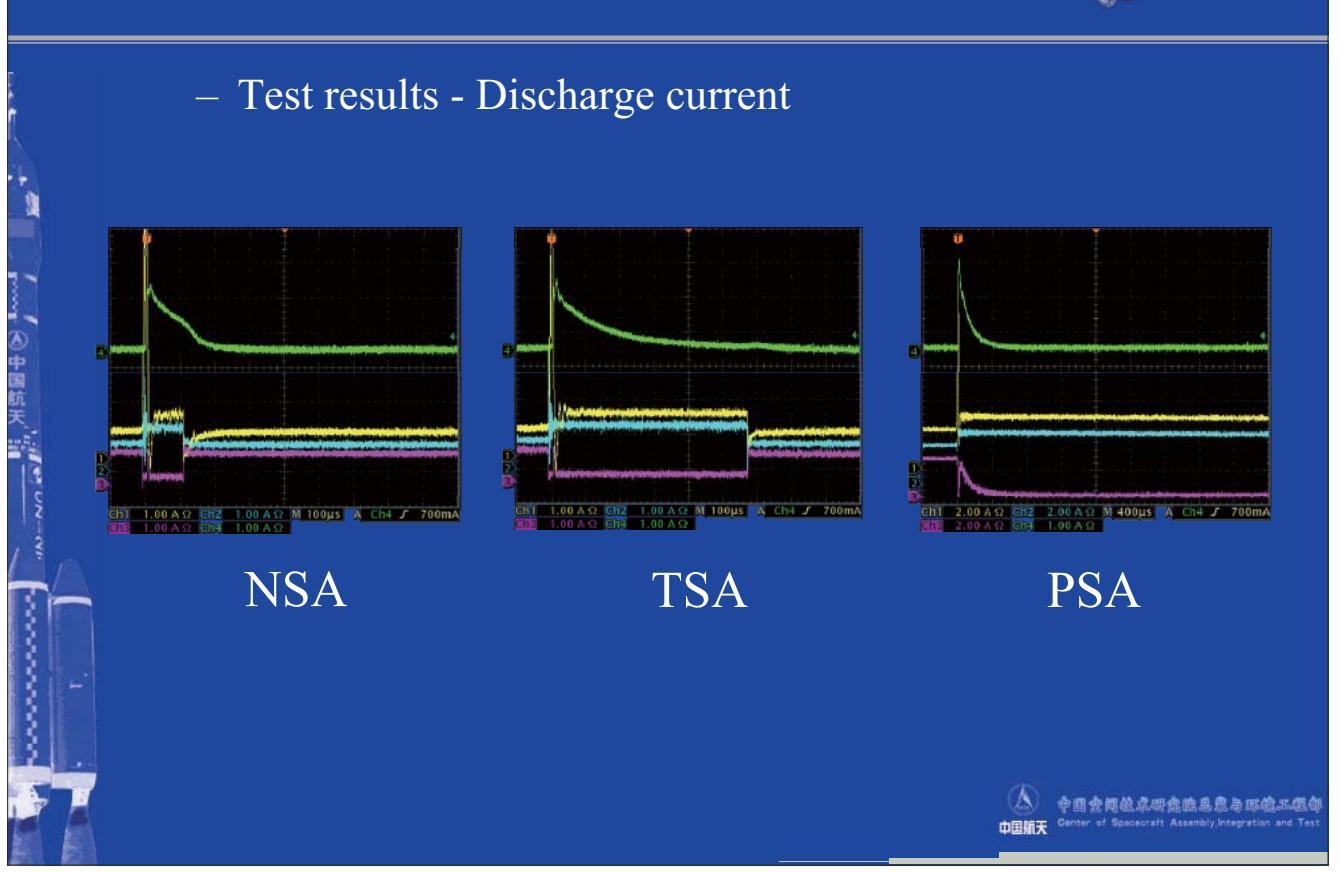
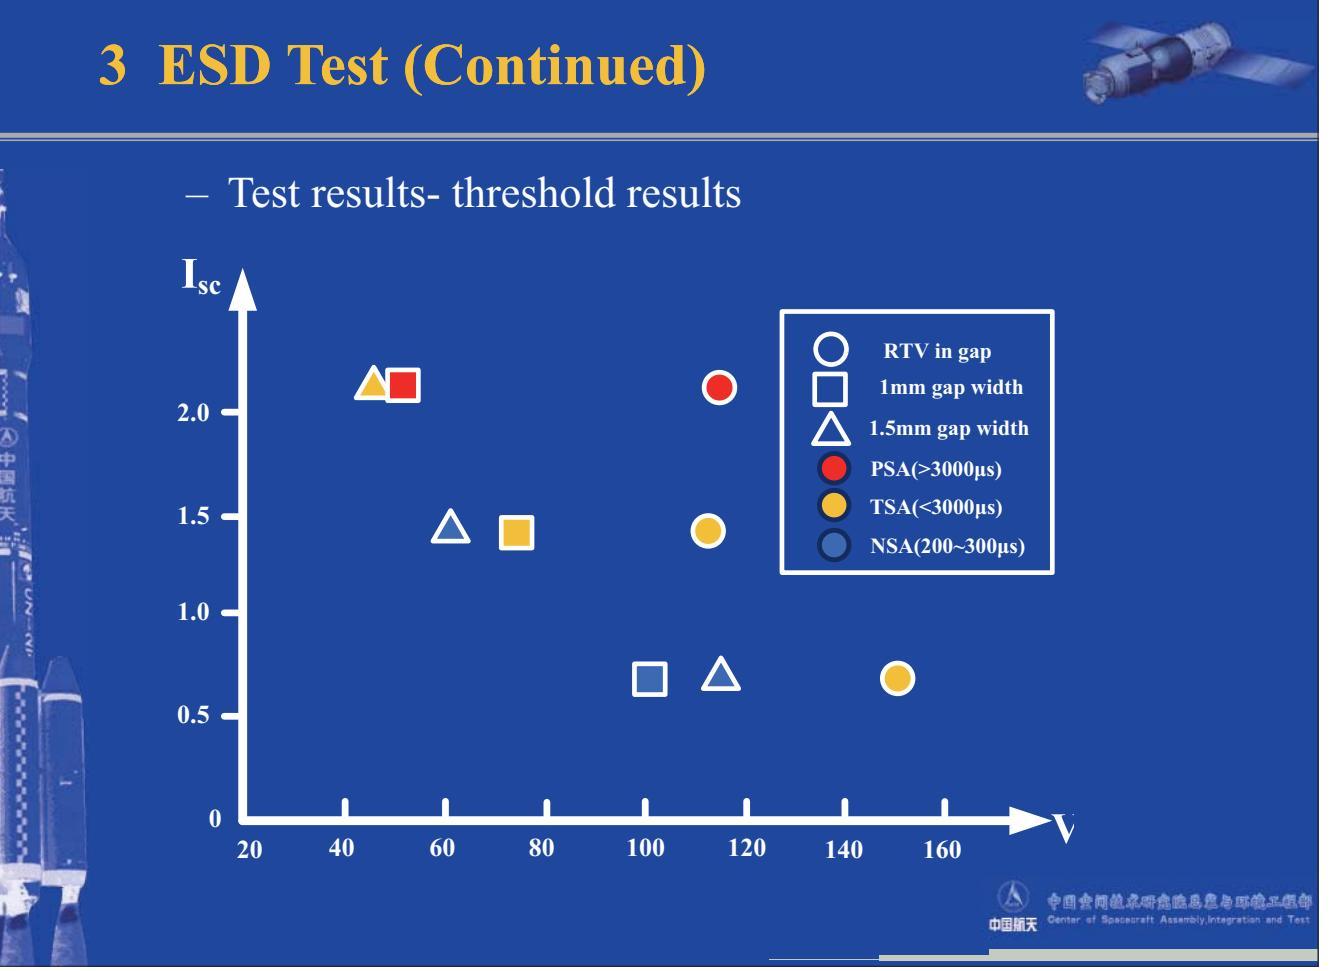
Second discharge threshold results

Plasma	N _i	Ter	nperature kT _e	
9.	57×10^{12}	² m ⁻³		3.03eV	
	C _{ext}	R _{ext}	L _{ext}	Bias V _b	R _b
	2µF	94Ω	8mH	-200V	10kΩ
				Capaci	tance
				C1=C2=20nF	, C3=21nF

Voltage step	Current	Numbers of PA
5V	0.7A/1.4A/2.1A	40PA

Grouting	I/A	0.7	1.4	2.1
Gap=1mm	U/V	150(NSA)	120(TSA)	115(PSA)
No grouting	I/A	0.7	1.4	2.1
Gap=1mm	U/V	100(NSA)	75(TSA)	55(PSA)
No grouting	I/A	0.7	1.4	2.1
Gap=1.5mm	U/V	115(NSA)	60(NSA)	55(TSA)

3) Secondary discharge threshold is about 100V for 1mm-RTV grouting coupon.

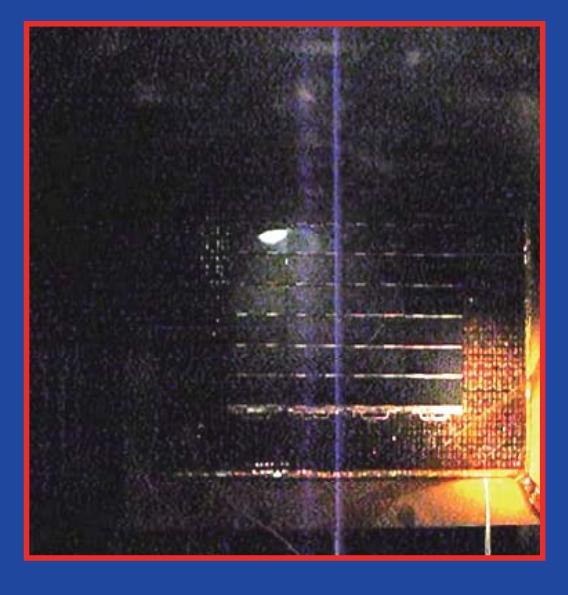
d) Power leakage to plasma test

- Test coupons:
 - Silicon solar cells
 - 4s7p
 - Gap distance: 1mm

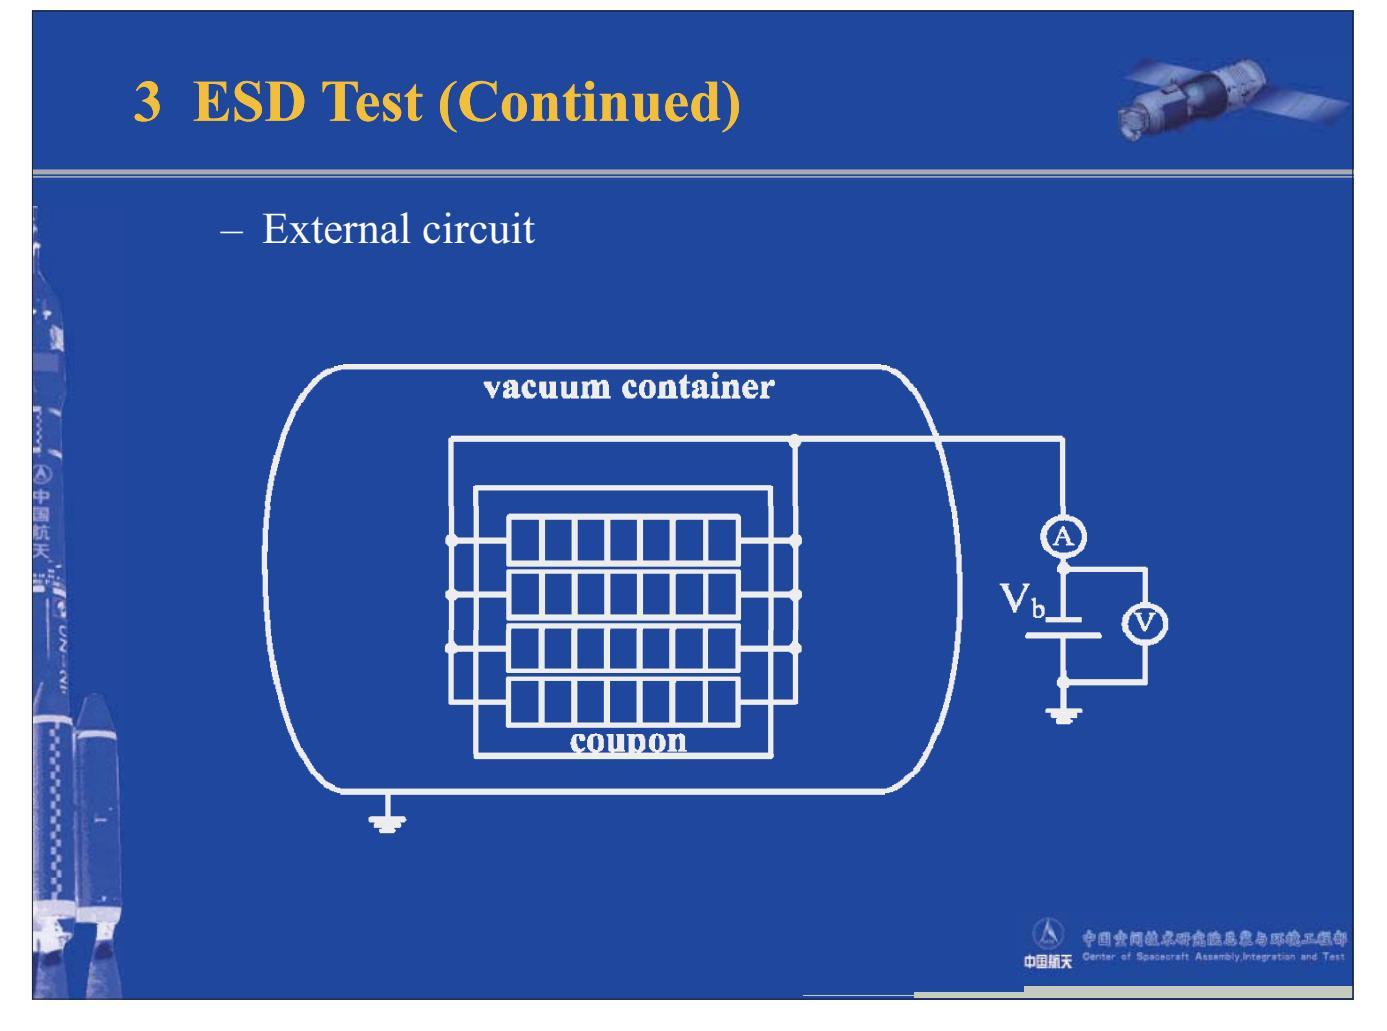
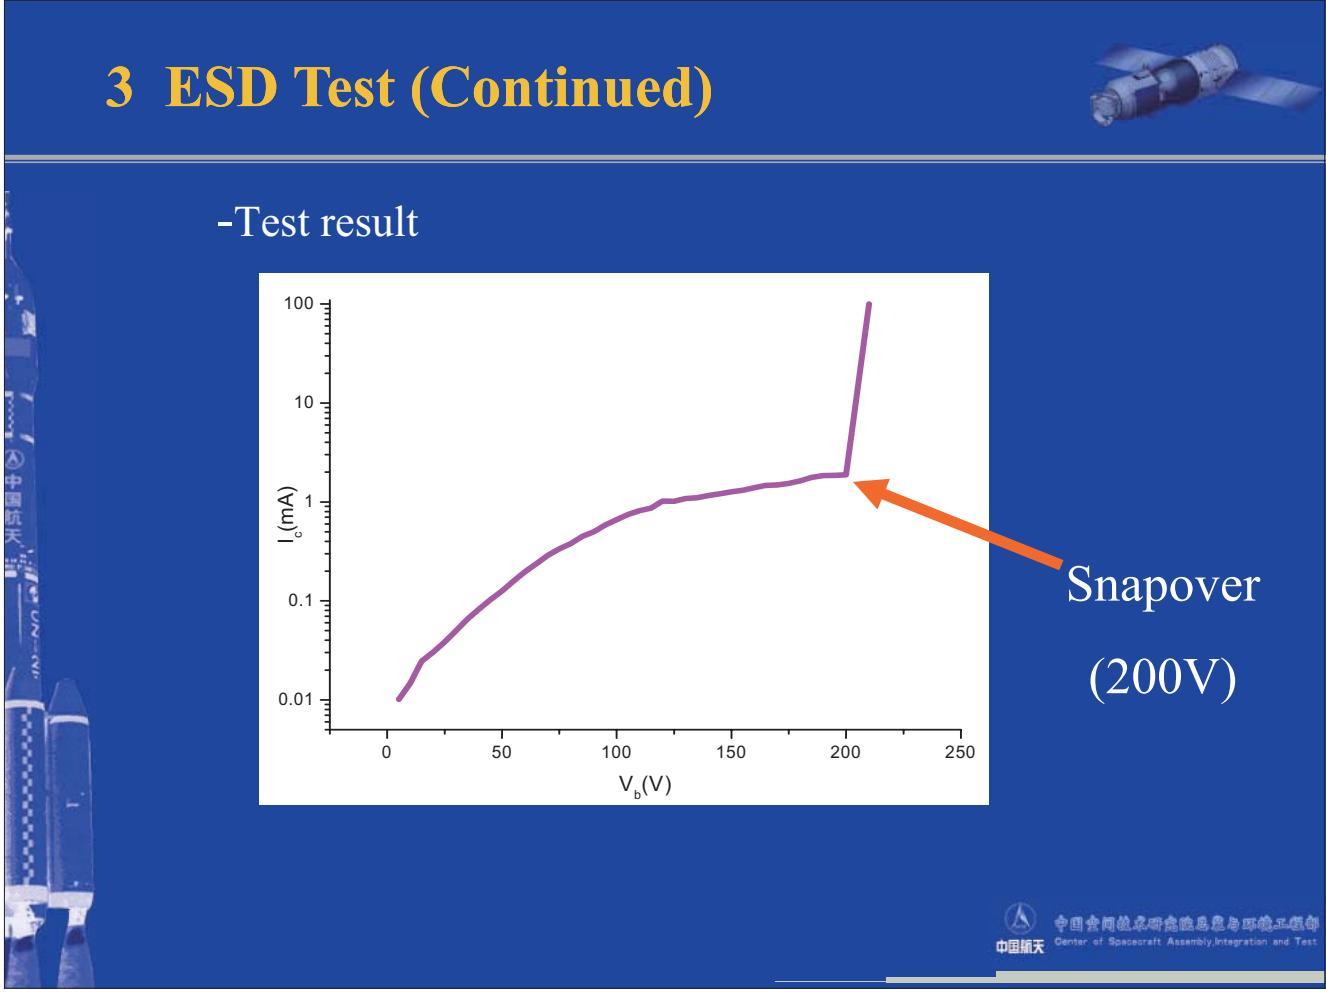
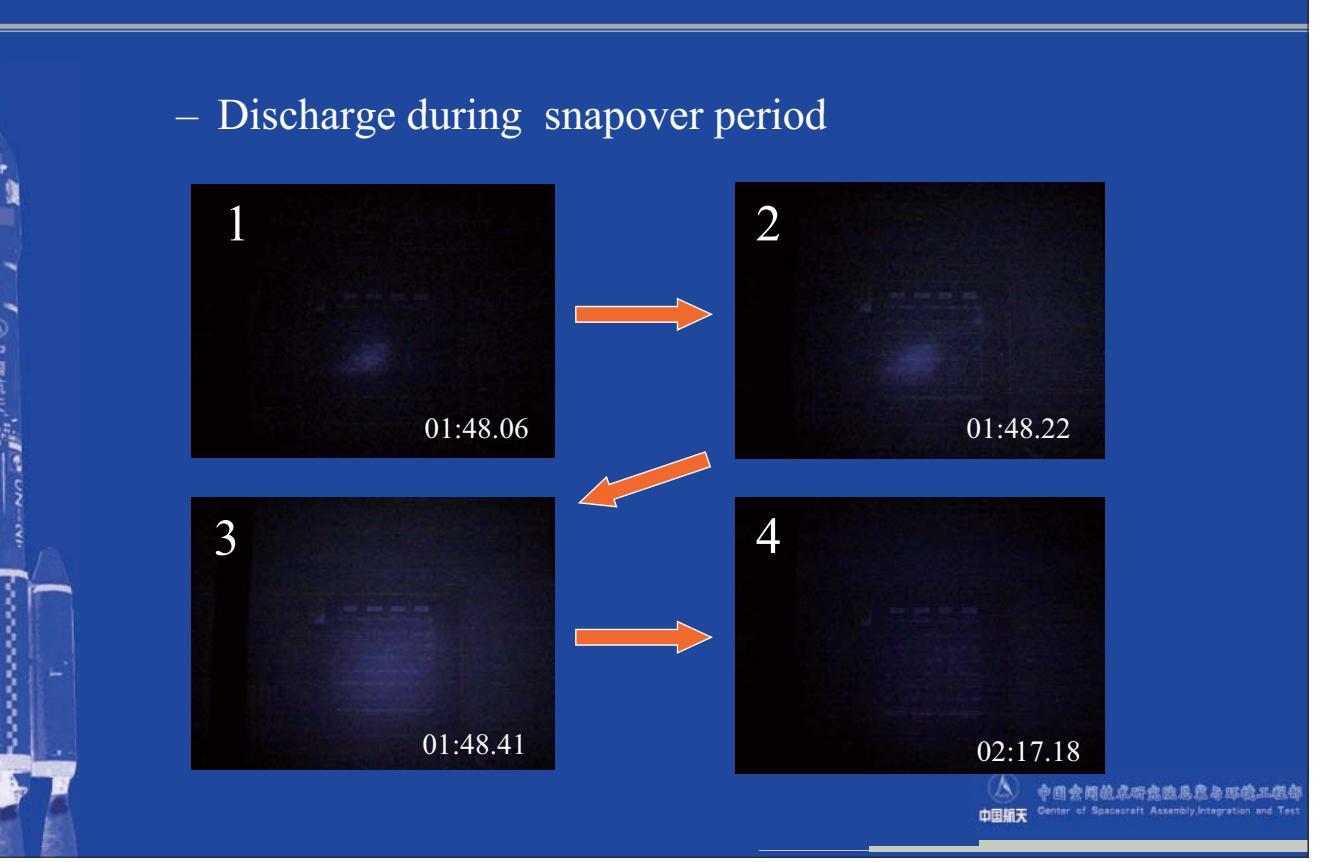
Plasma density N _i	Temperature kT _e
$9.1 \times 10^{12} \mathrm{m}^{-3}$	8.0eV
Bias V _b	$0V\sim 210V$
Voltage step	Waiting time
0.1V	1min

4) Snapover happened at about 200V, the current is more than 200mA, duration is about 1minut.
